## Earthquake-Induced Deformations in Embankment Dams: Darbandikhan Dam as a Case Study

Kawa Zaidan Abdulrahman, Omed S. Q. Yousif, Younis Alshkane, Abdulrahman Khani  
University of Sulaimani  
Iraq

## Darbandikhan Dam

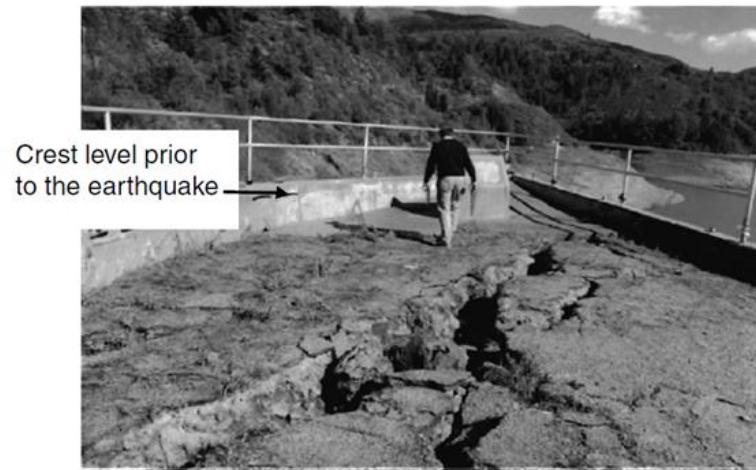
Austrian Dam – 55 m high - October 17, 1989 Loma Prieta Earthquake –  $M = 7.1$ .

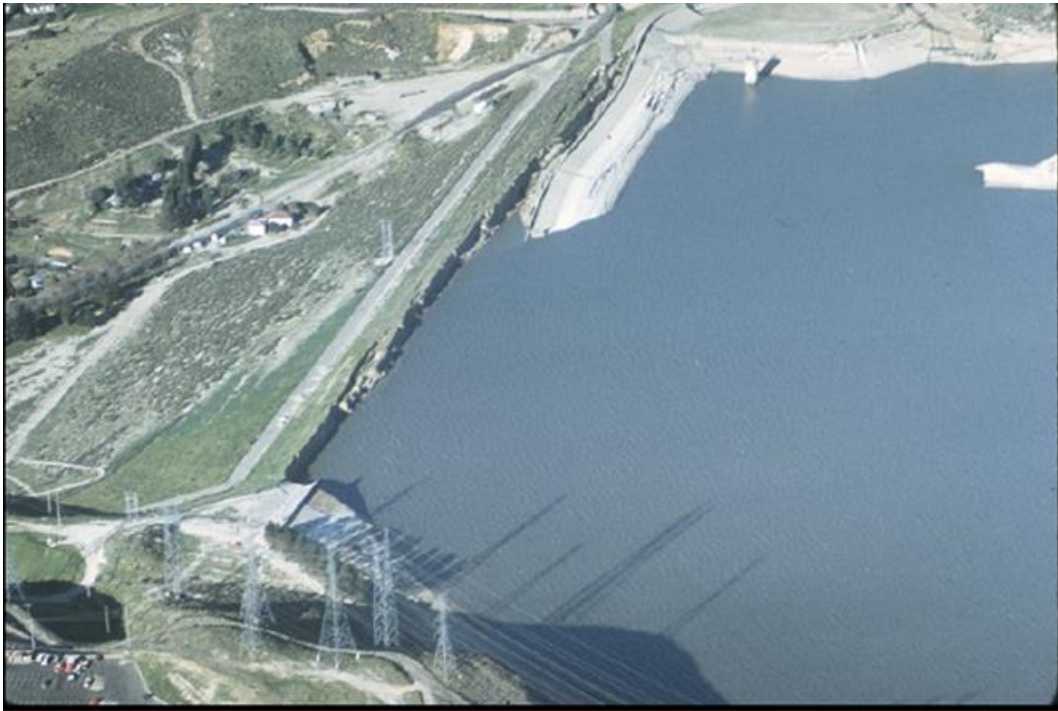
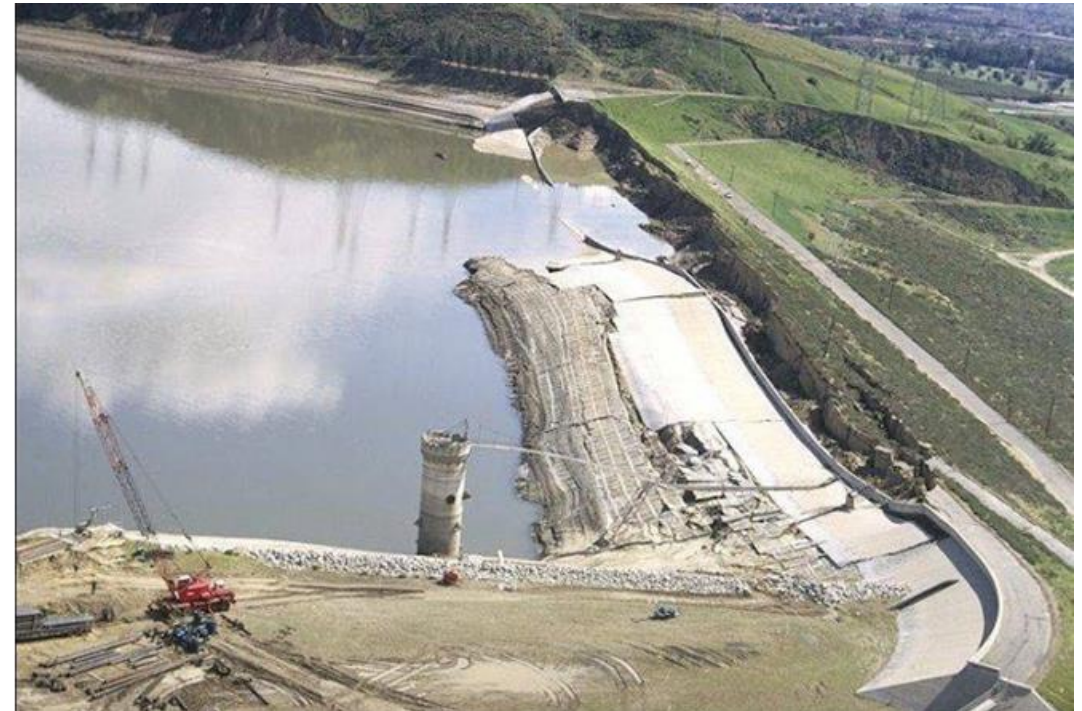
Lower San Fernando Dam after Upstream Slope Slide in Earthquake of Feb . 9, 1971 – M = 6.6 San Fernando earthquake produced about 0.55 g peak acceleration at the dam crest.

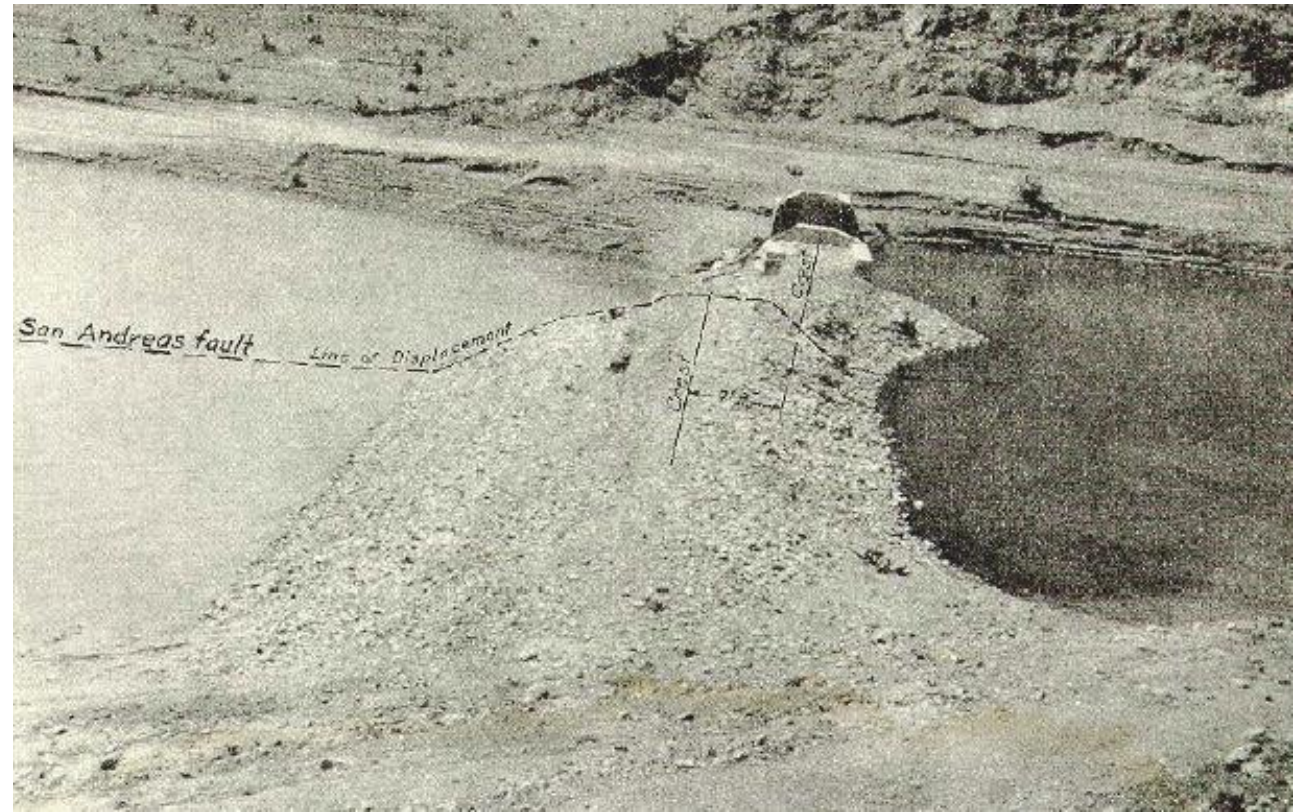
San Andreas Dam, CA (1906) Fault Rupture  
The devastating magnitude Mw 7.7–7.9 San Francisco

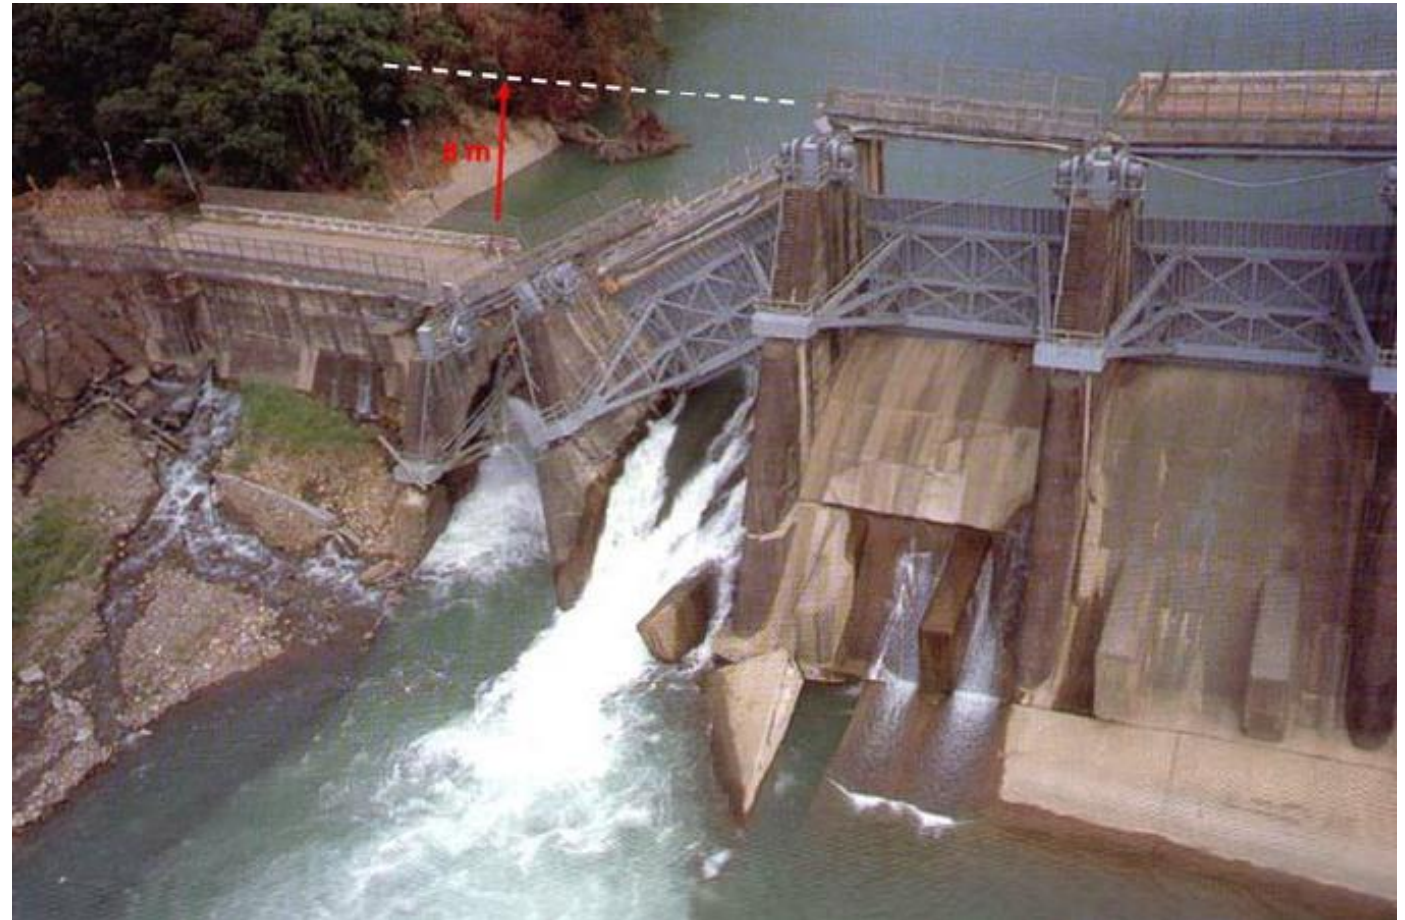
Chelungpu-thrust-fault-Chi-Chi-Taiwan-1999-earthquake-Shih-Kang-Dam

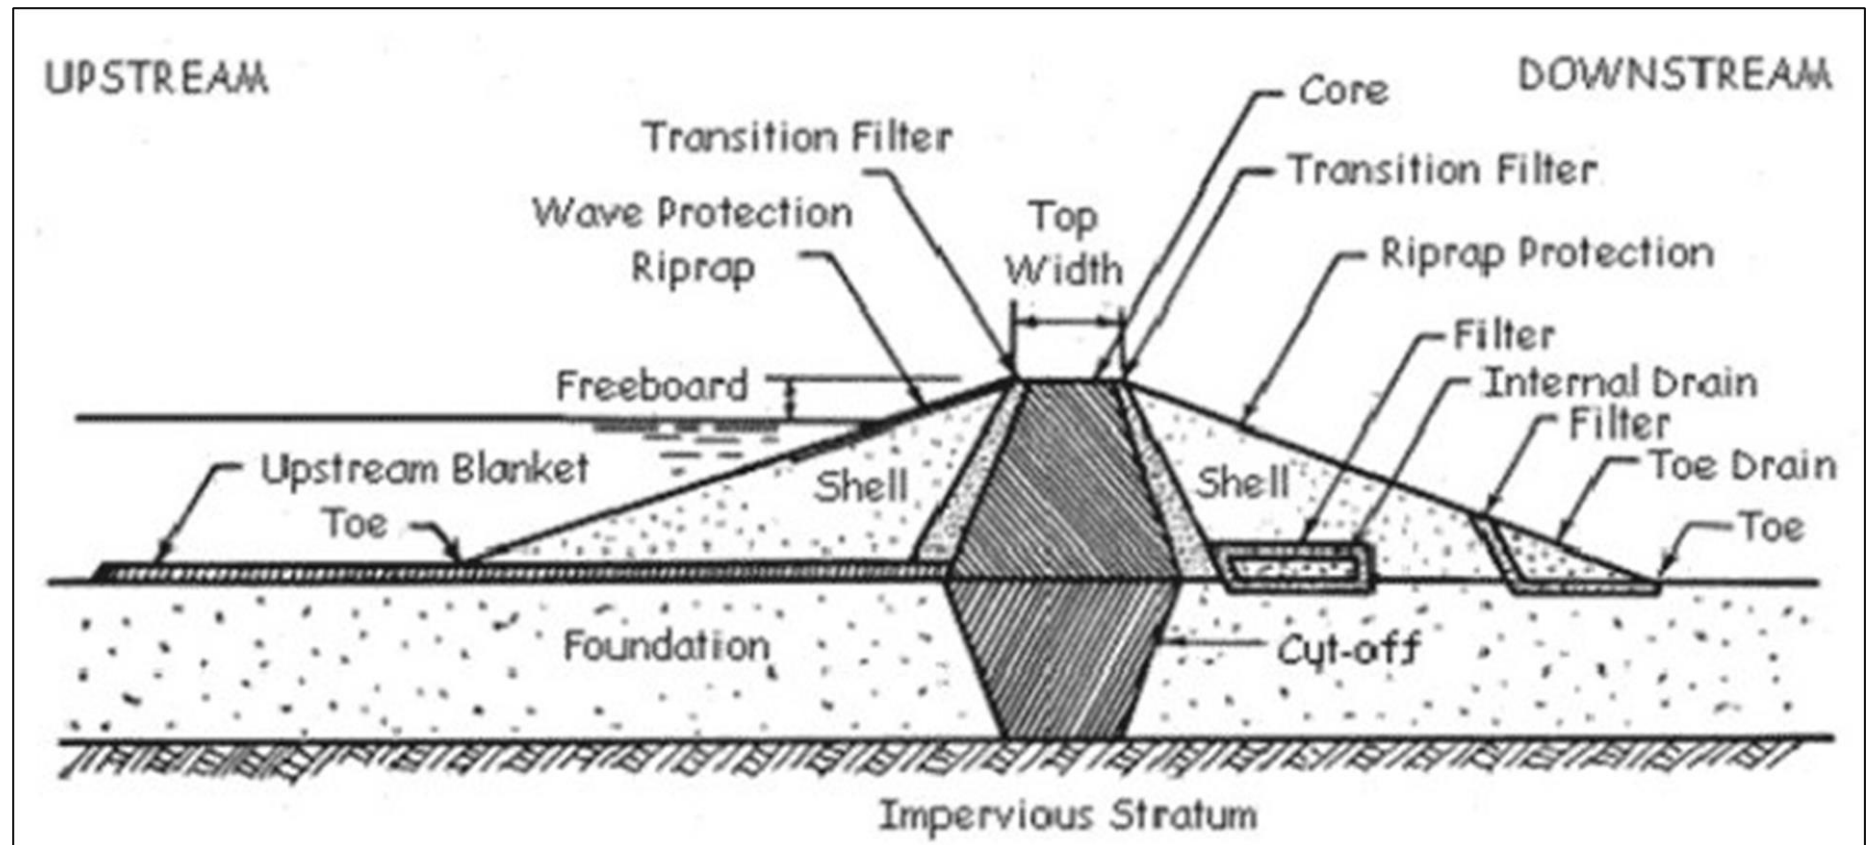
1. There is no Toe Drain which is essential for the Inspection of seepage through the dam body.

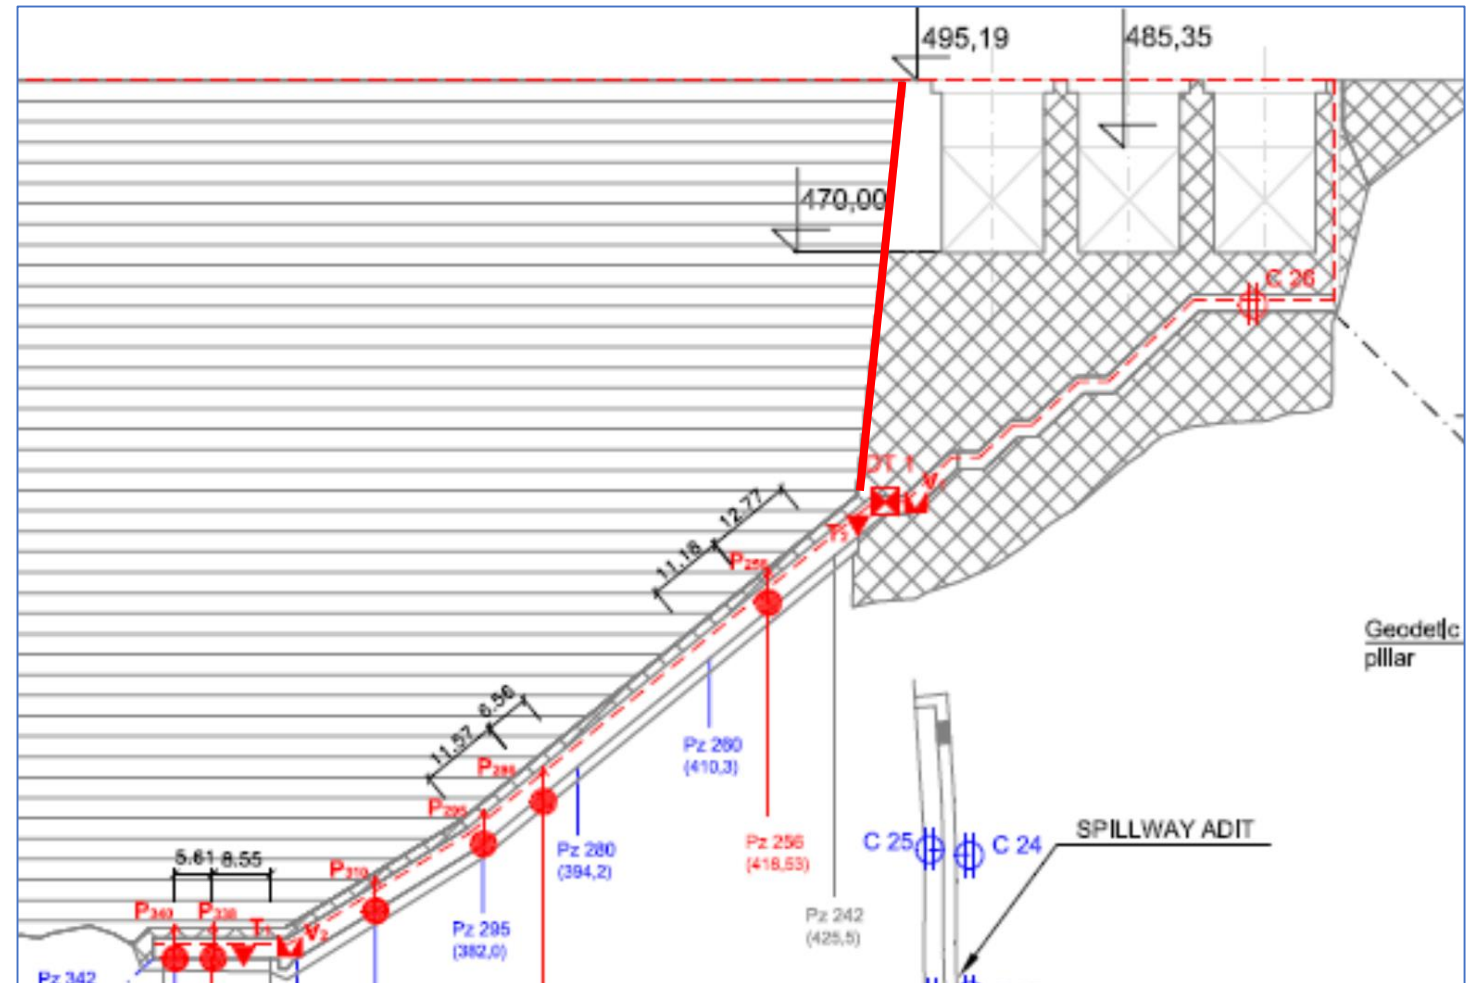
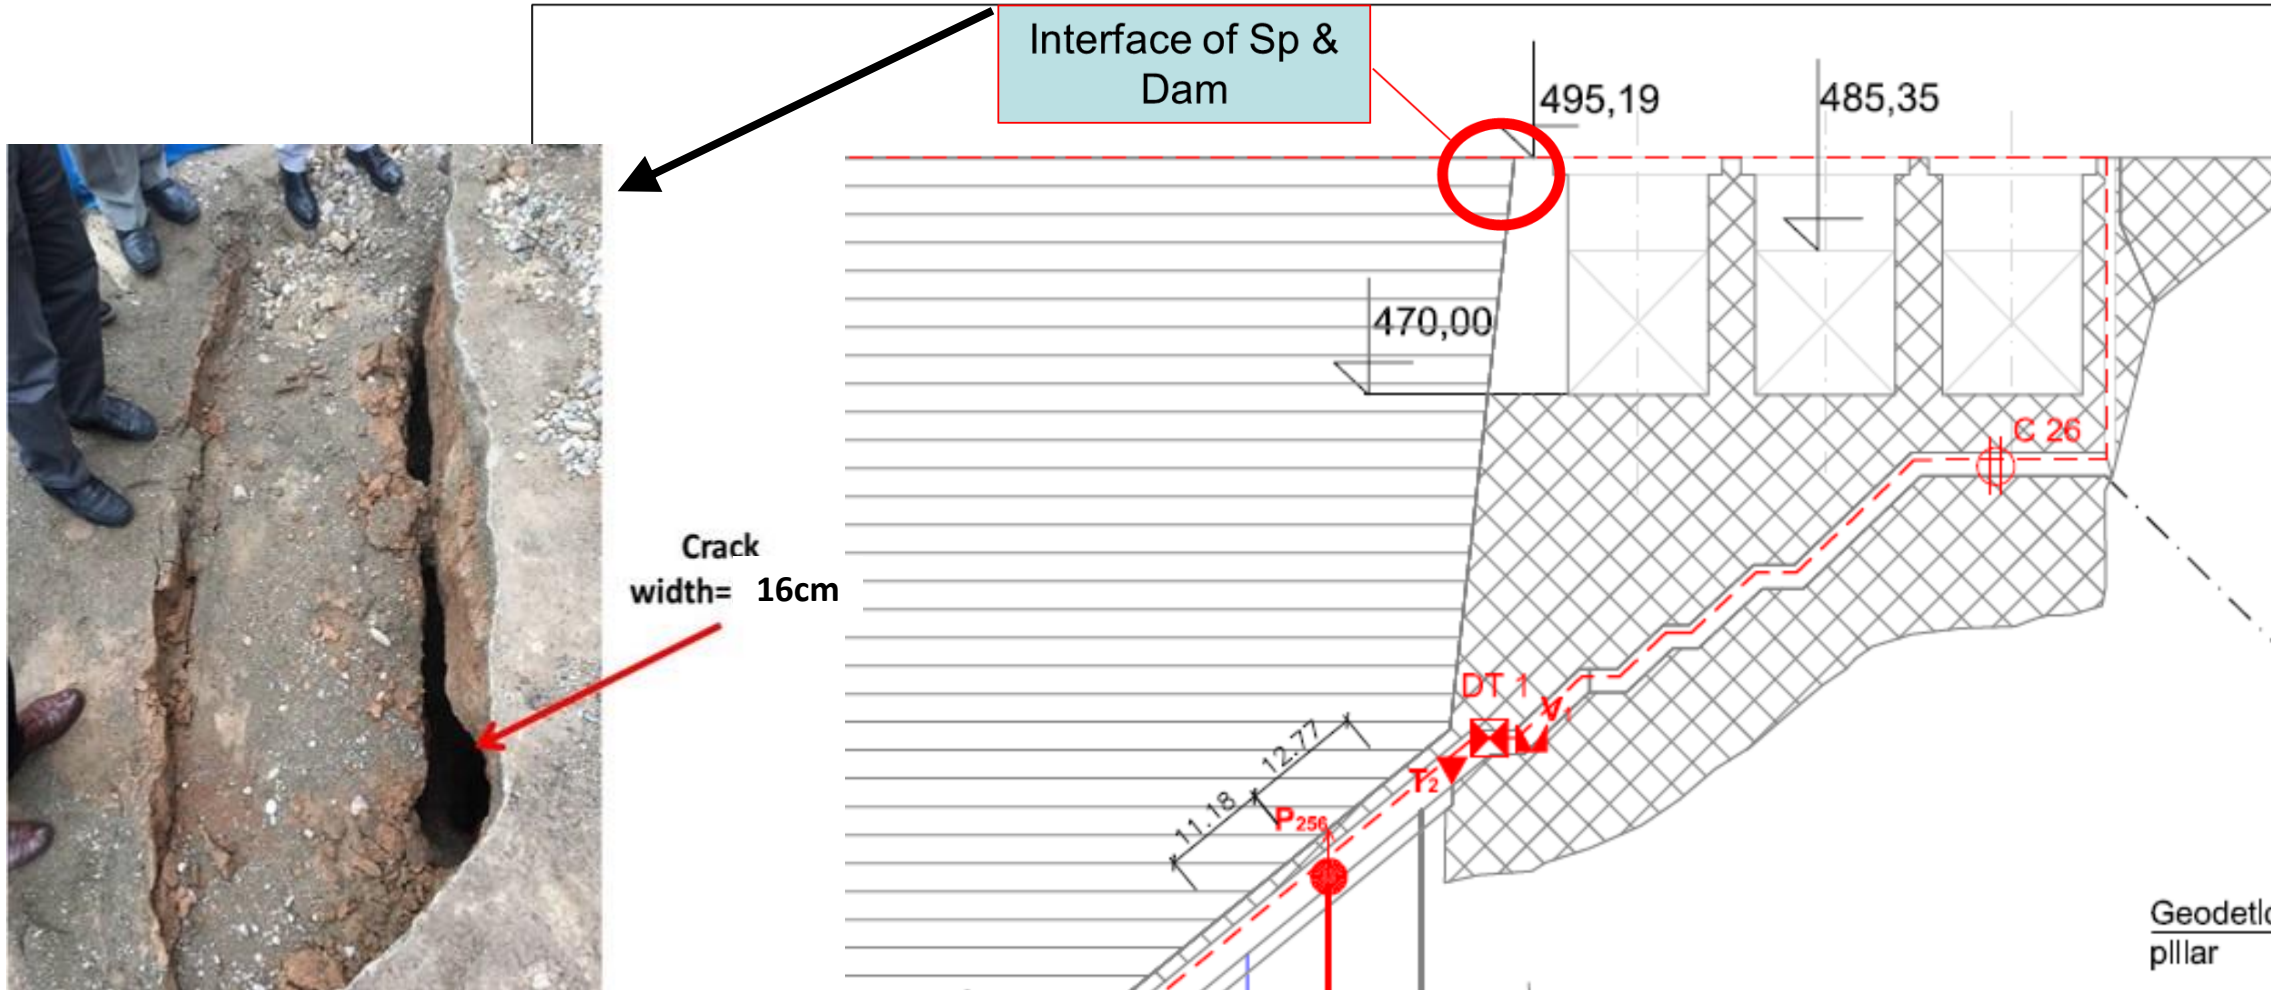
2- Spillway-Embankment interface

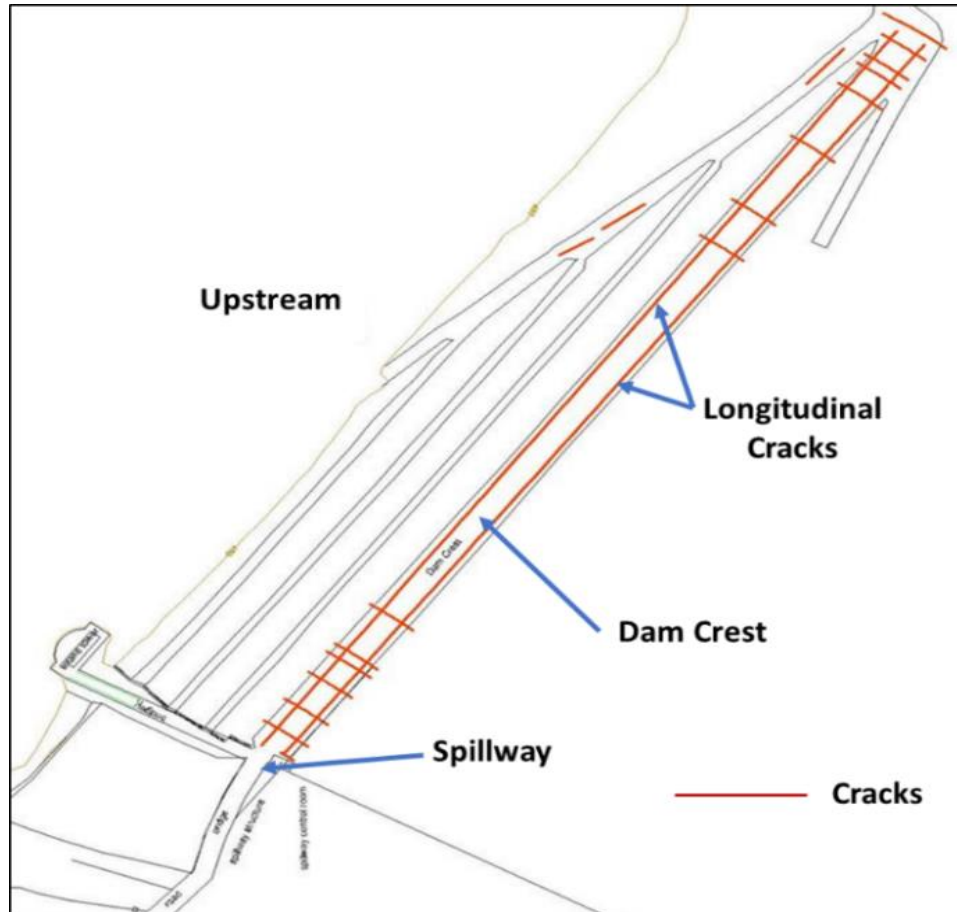
**Figure 5.** Crack pattern

For Darbandikhan dam, the width of the major transverse crack that occurred in the clay core next to the spillways structure was about **16 cm**. So, the estimated depth of this major crack should be between **2.4 m** and **16 m** from the top of the clay core (i.e. it may go down from elevation 490.6 m to elevation 479 m).

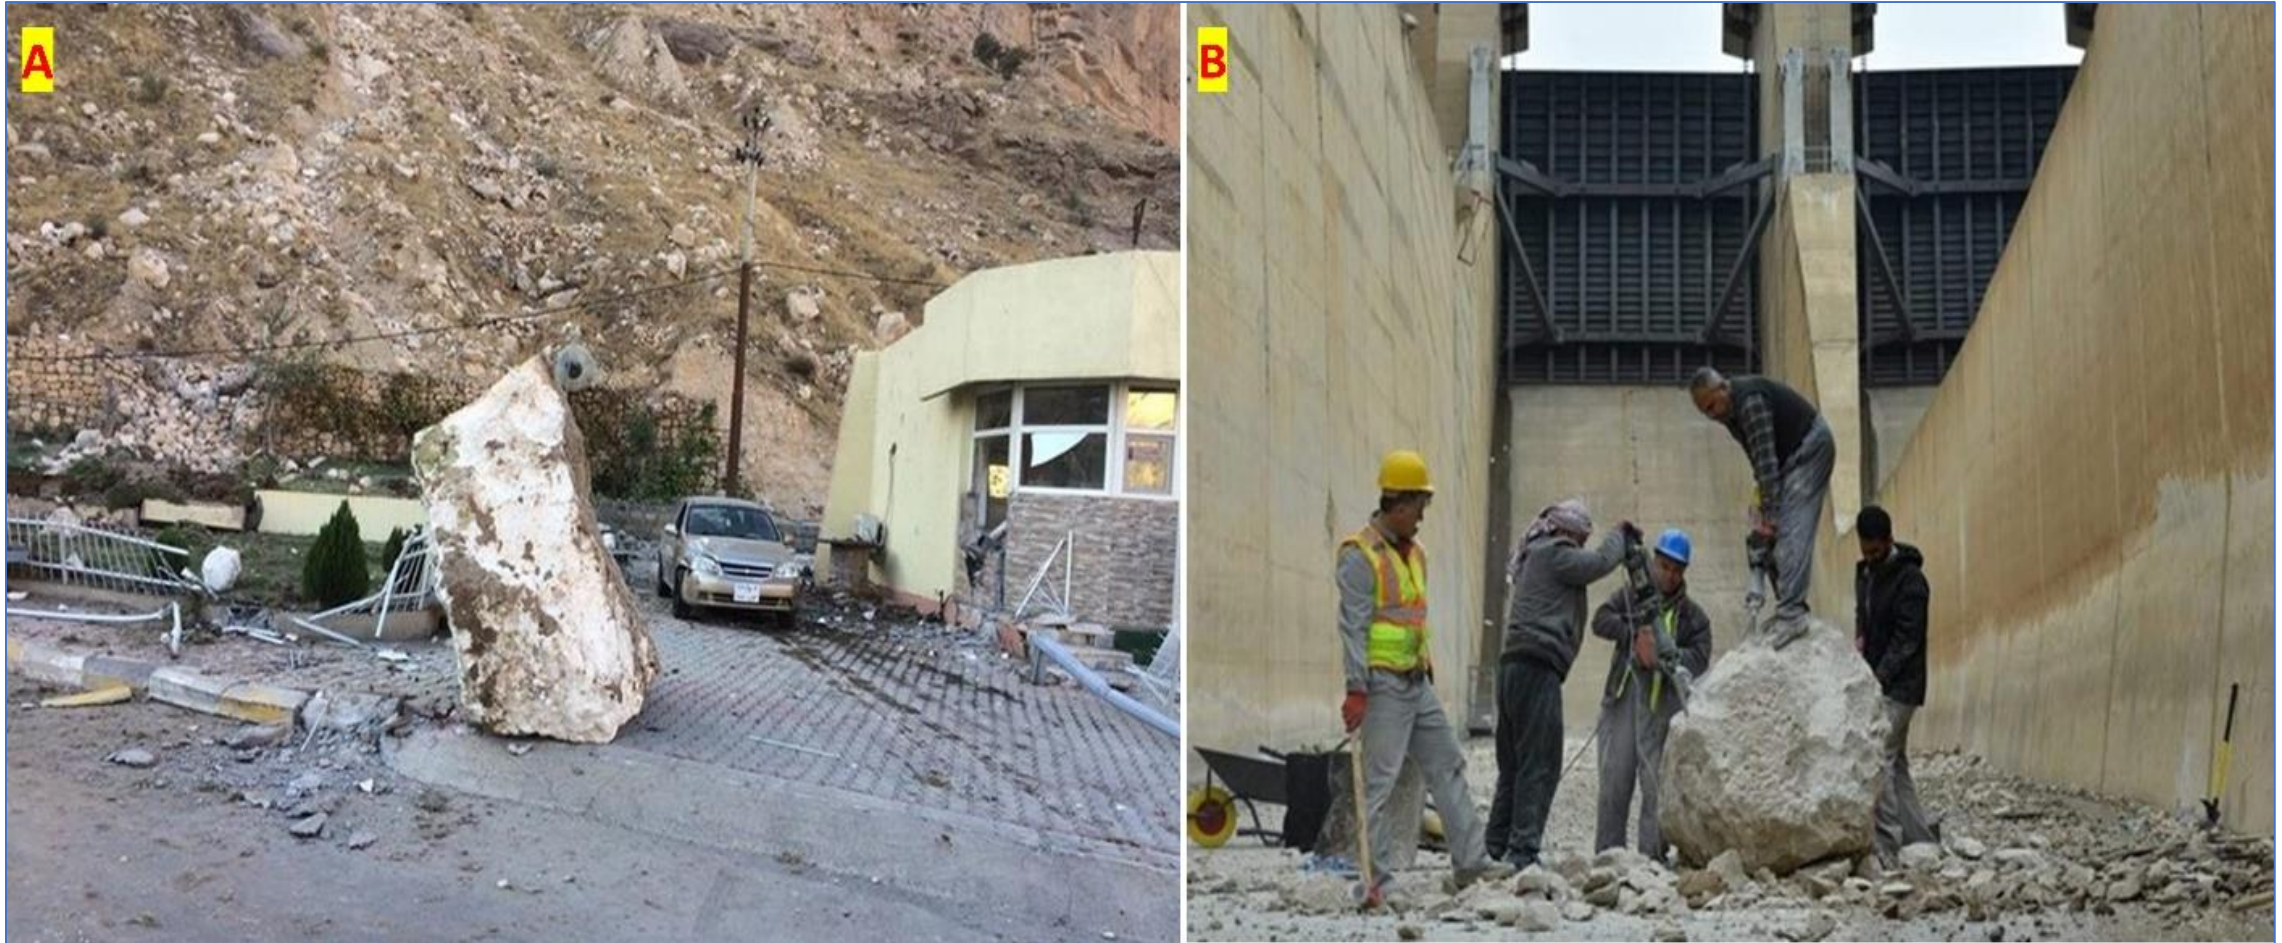
**Figure 6:** **A-** The Control Room, **B-** Pieces of Rock Fall at the Spillway Chute.

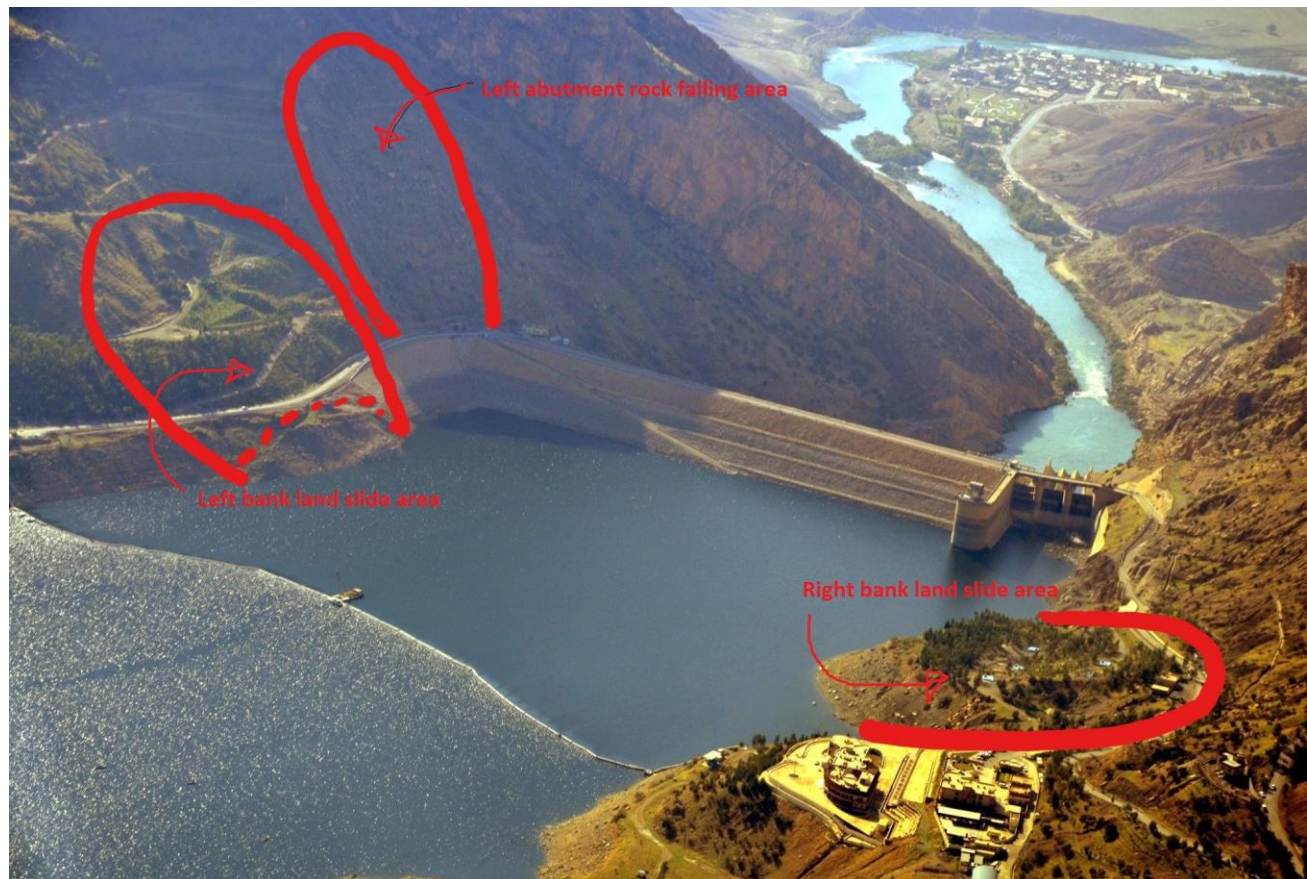
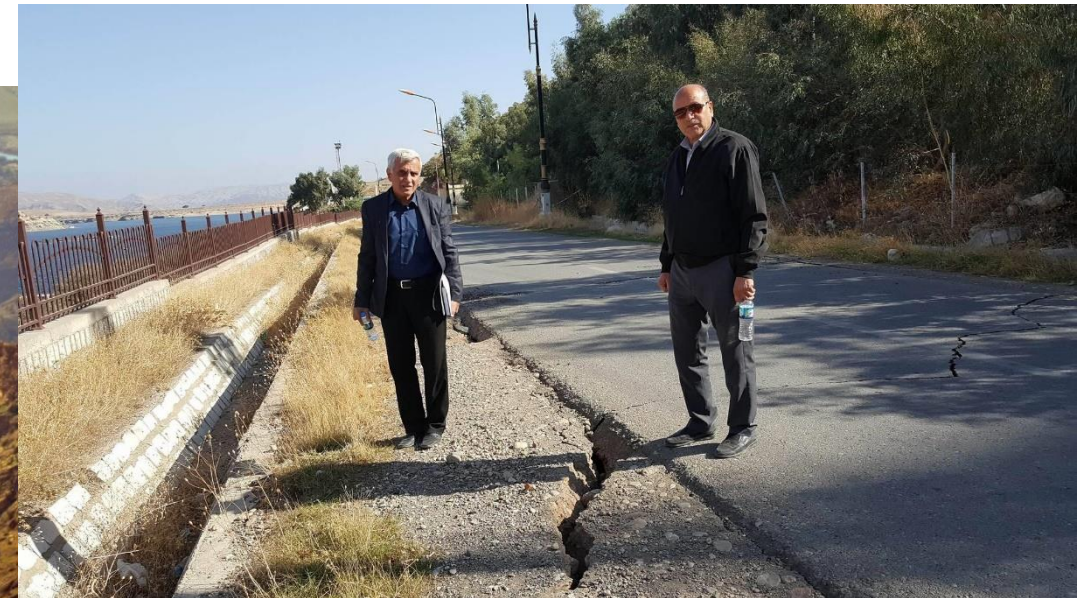
**Figure 7:** Left & right bank sliding
