Themes # 2 Monitoring of Dams

Technical Monitoring of the HPP “Piva” Dam

Author Name
Energoprojekt-Hidroinzenjering J.S.C.
Serbia

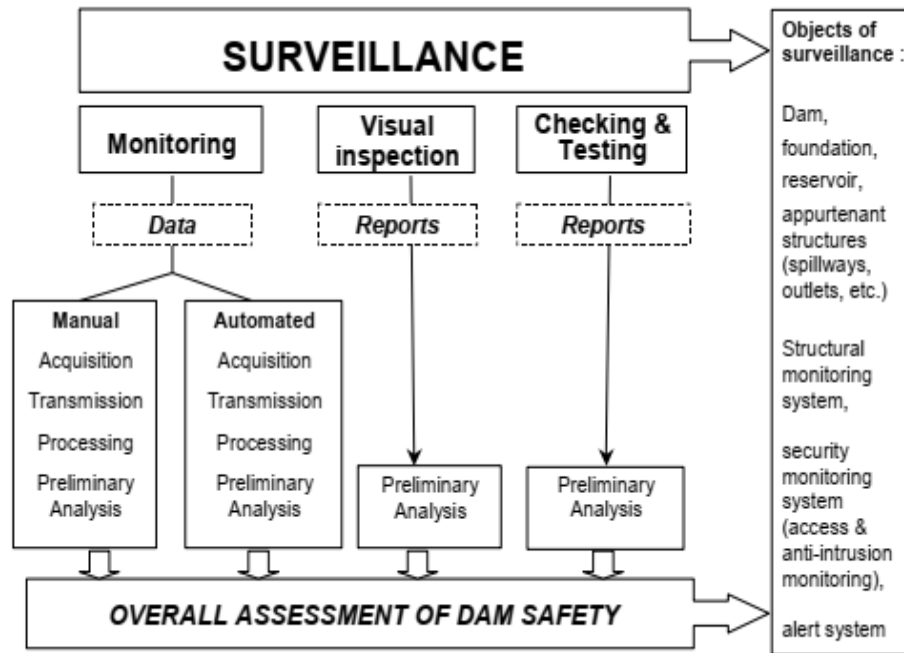
The following figure explains the extend of the definition of the concept of monitoring used in this project:

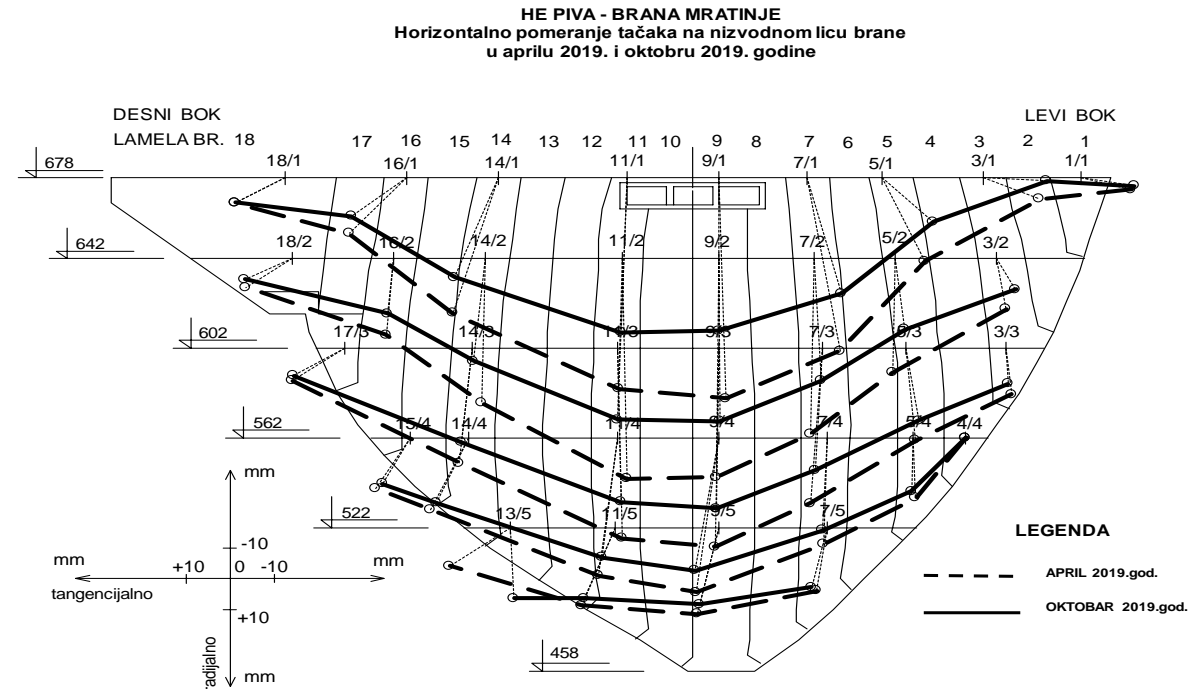
Horizontal displacements are determined in relation to the monitoring points at the dam downstream face, arranged in five levels with elevations of 522.0 masl, 562.0 masl, 602.0 masl, 642.0 masl, 678.0 masl, which is a total of 34 points.

Vertical displacements are determined for points set on the dam crest. There are 40 points at the upstream, and 40 points at the downstream side of the dam crest being monitored.

Geodetic measurements are performed by modern geodetic instruments, of high accuracy and precision.

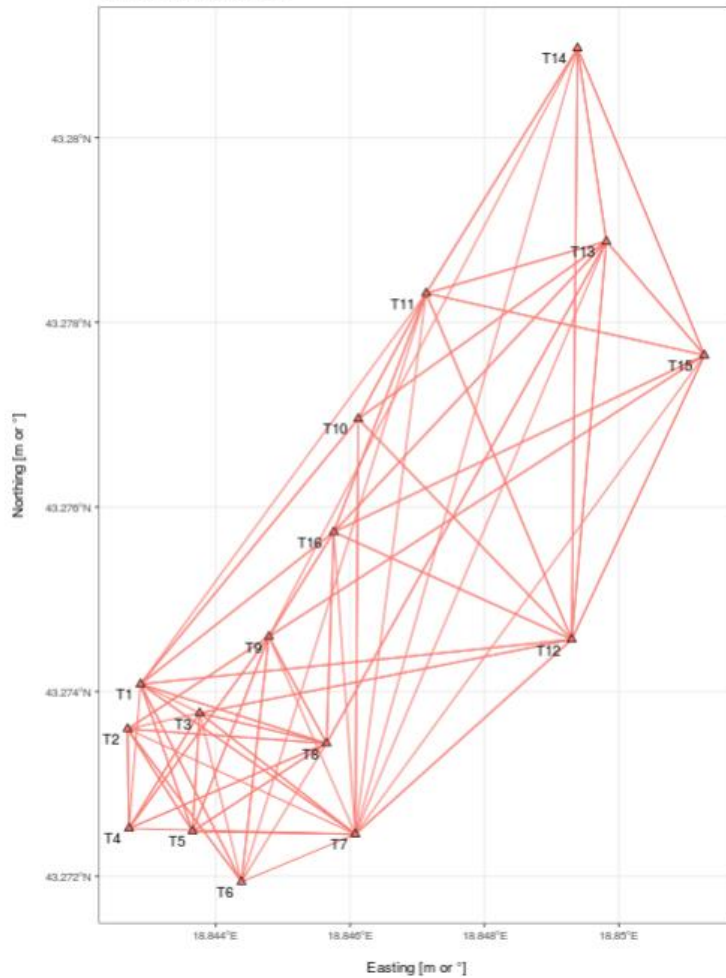
GEODETIC 2D NETWORK
Points and Observational plan

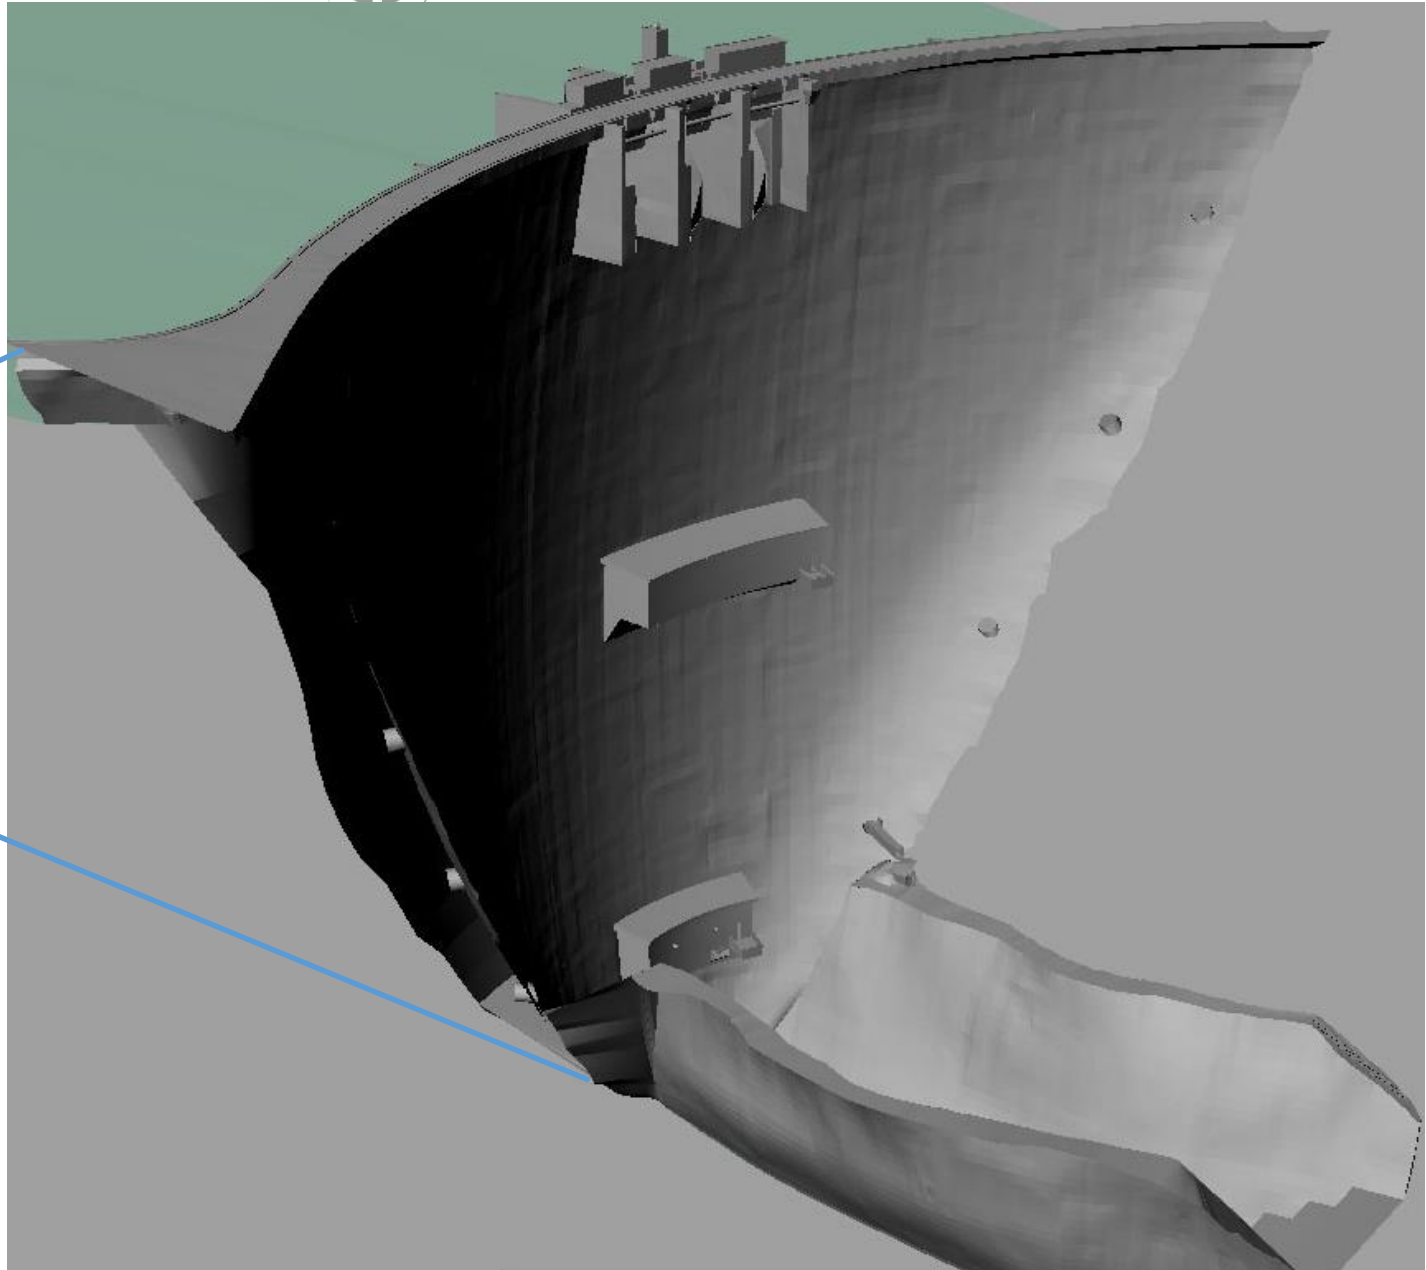
3D model of the HPP
“PIVA” dam obtained by
terrestrial laser scanning
