Dam Safety Practices in Turkey

Mutlu İlker Peker

The General Directorate of State Hydraulic Works of Turkey

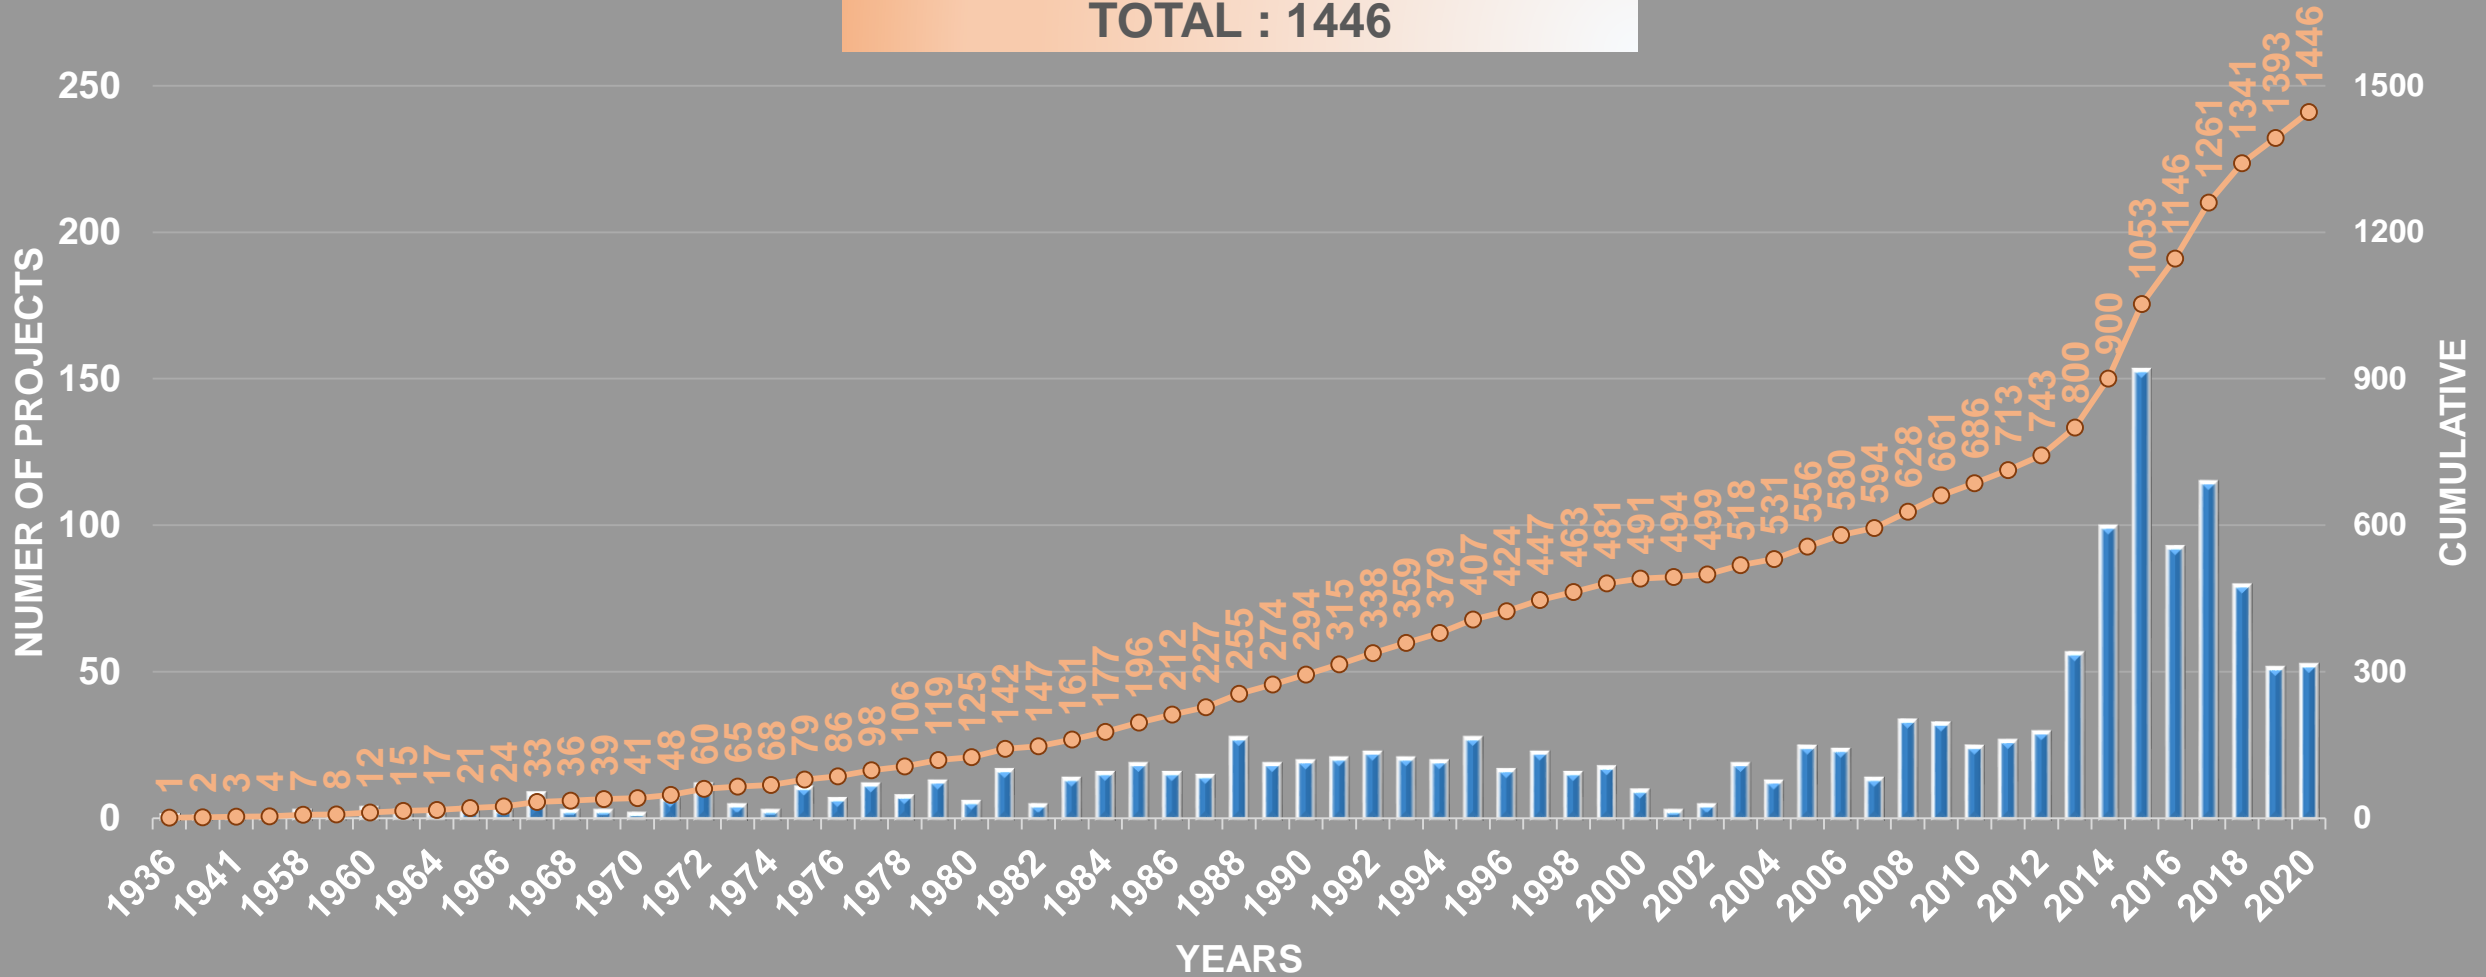
CONSTRUCTED DAMS BY YEARS
TOTAL : 1446

THE NUMBER OF CONSTRUCTED DAMS (1936 – 2020)

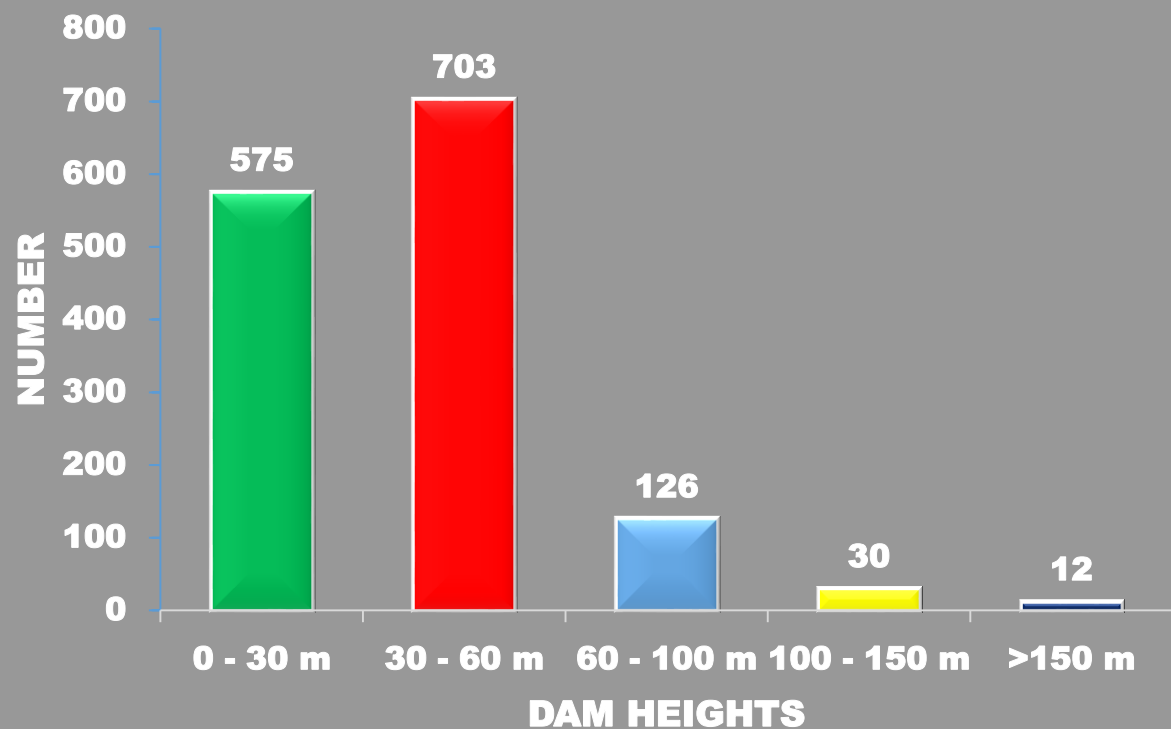
BY DAM HEIGHT
1 446 Dams

CONSTRUCTED DAMS IN TURKEY (1936 – 2020)

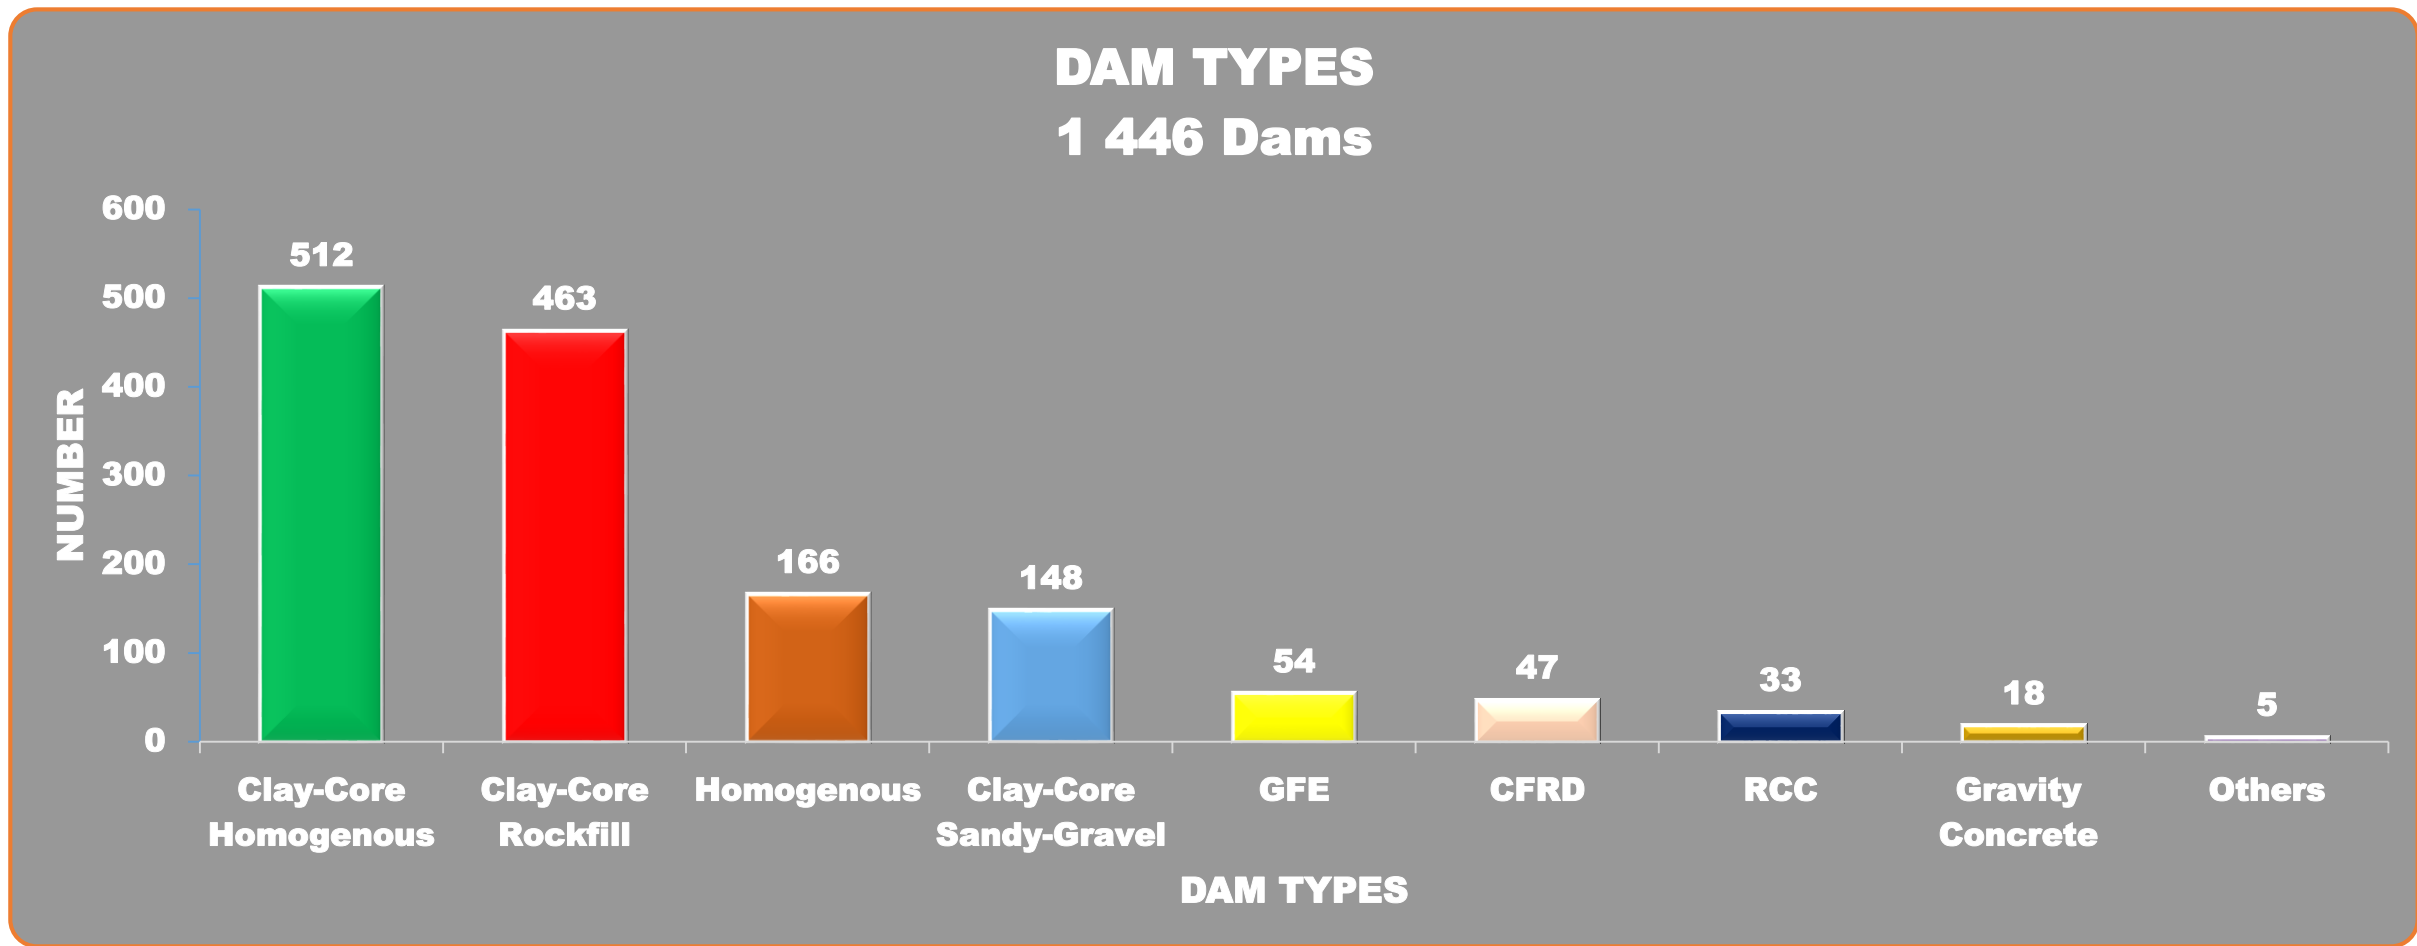
CONSTRUCTED DAMS BETWEEN 1936 – 2020

*GFE: Geomembrane Covered Embankments

*CFRD: Concrete-Faced Rockfill Dams

*RCC: Roller - Compacted Concrete Dams

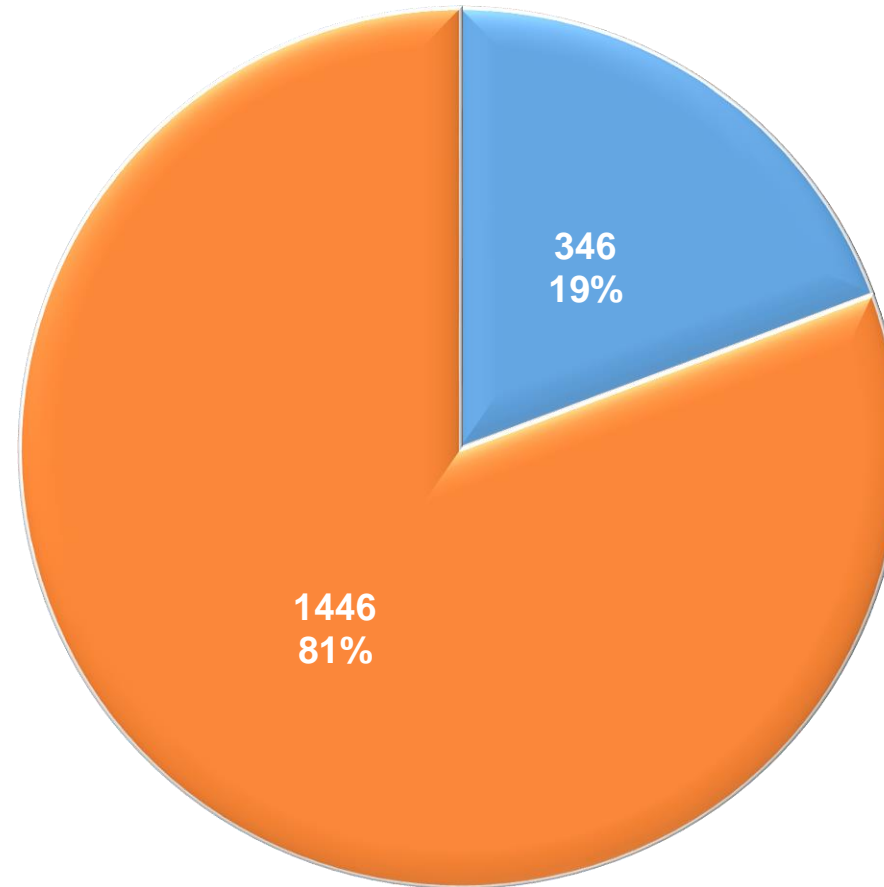
TOTAL : 1792

DAMS IN OPERATION AND UNDERCONSTRUCTION SINCE 1936

Under Construction Completed

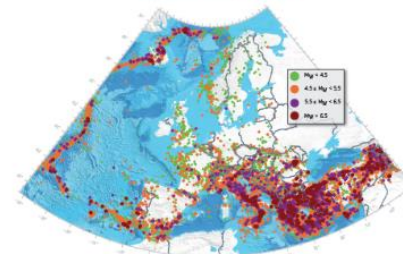
Earthquake History in Europe

Distribution of over 30,000 earthquakes with magnitudes larger or equal to 3.0 for the period 1000 - 2007, documented by their damaging effects through history or recorded with modern instrumental instruments.

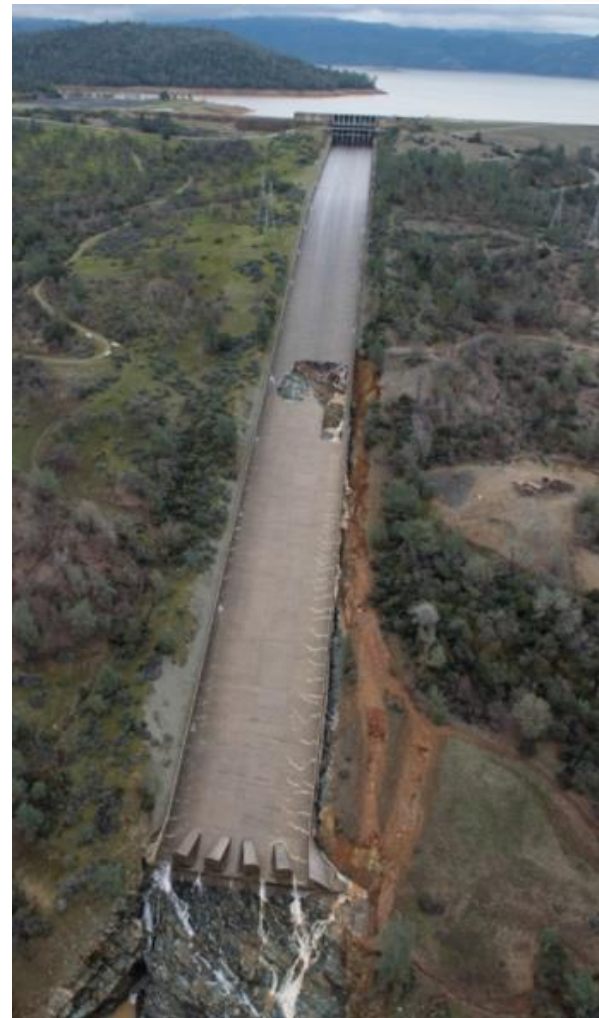
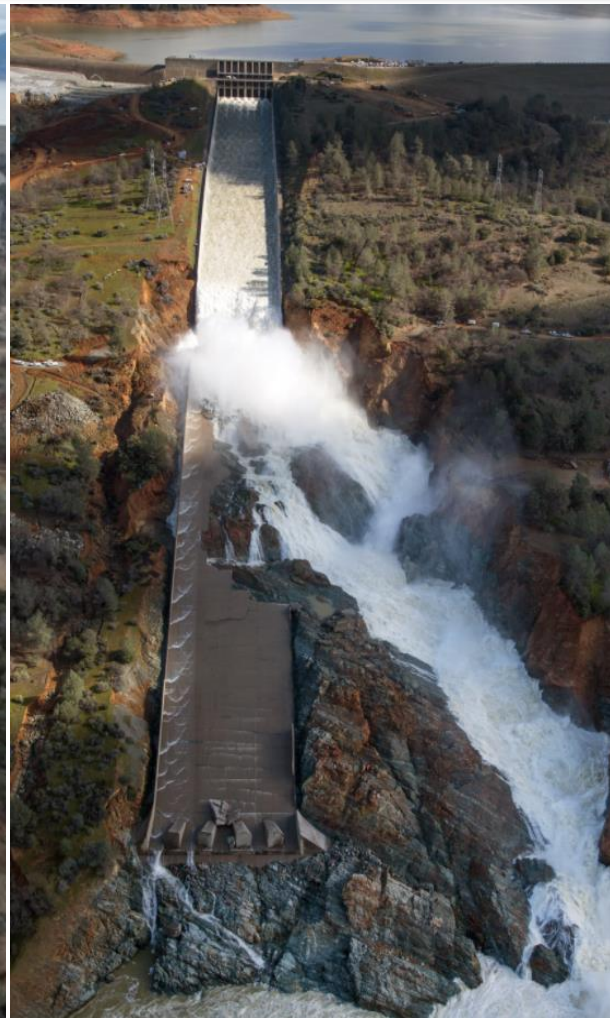
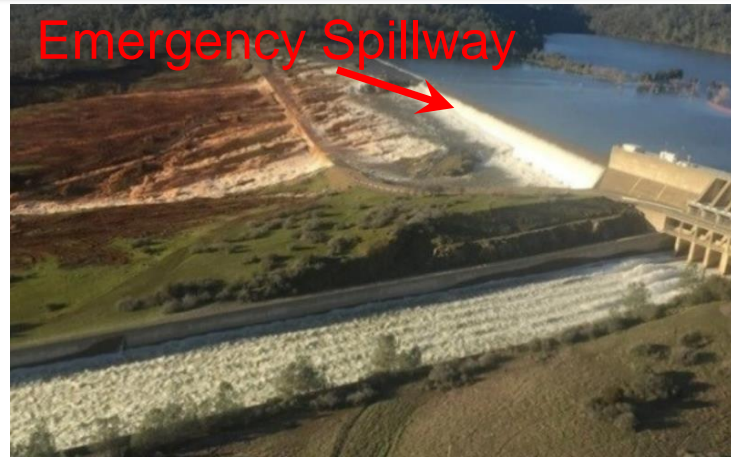
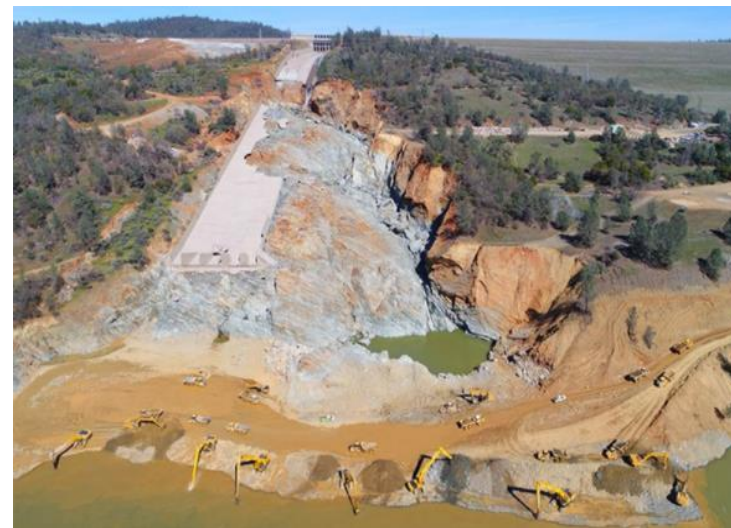
Oroville Dam (235 m), CA-USA

In 2017, the tallest dam in the USA has suffered from spillway failure, which was followed by rapid erosion of foundation.

To control the damage, the flow rate was decreased, which resulted in overtopping of emergency spillway.

Overtopping or sliding instabilities of ogee weir structure emerged.
180,000 evacuated.
Repair cost 1.1 Billion \$.
(damfailures.org)

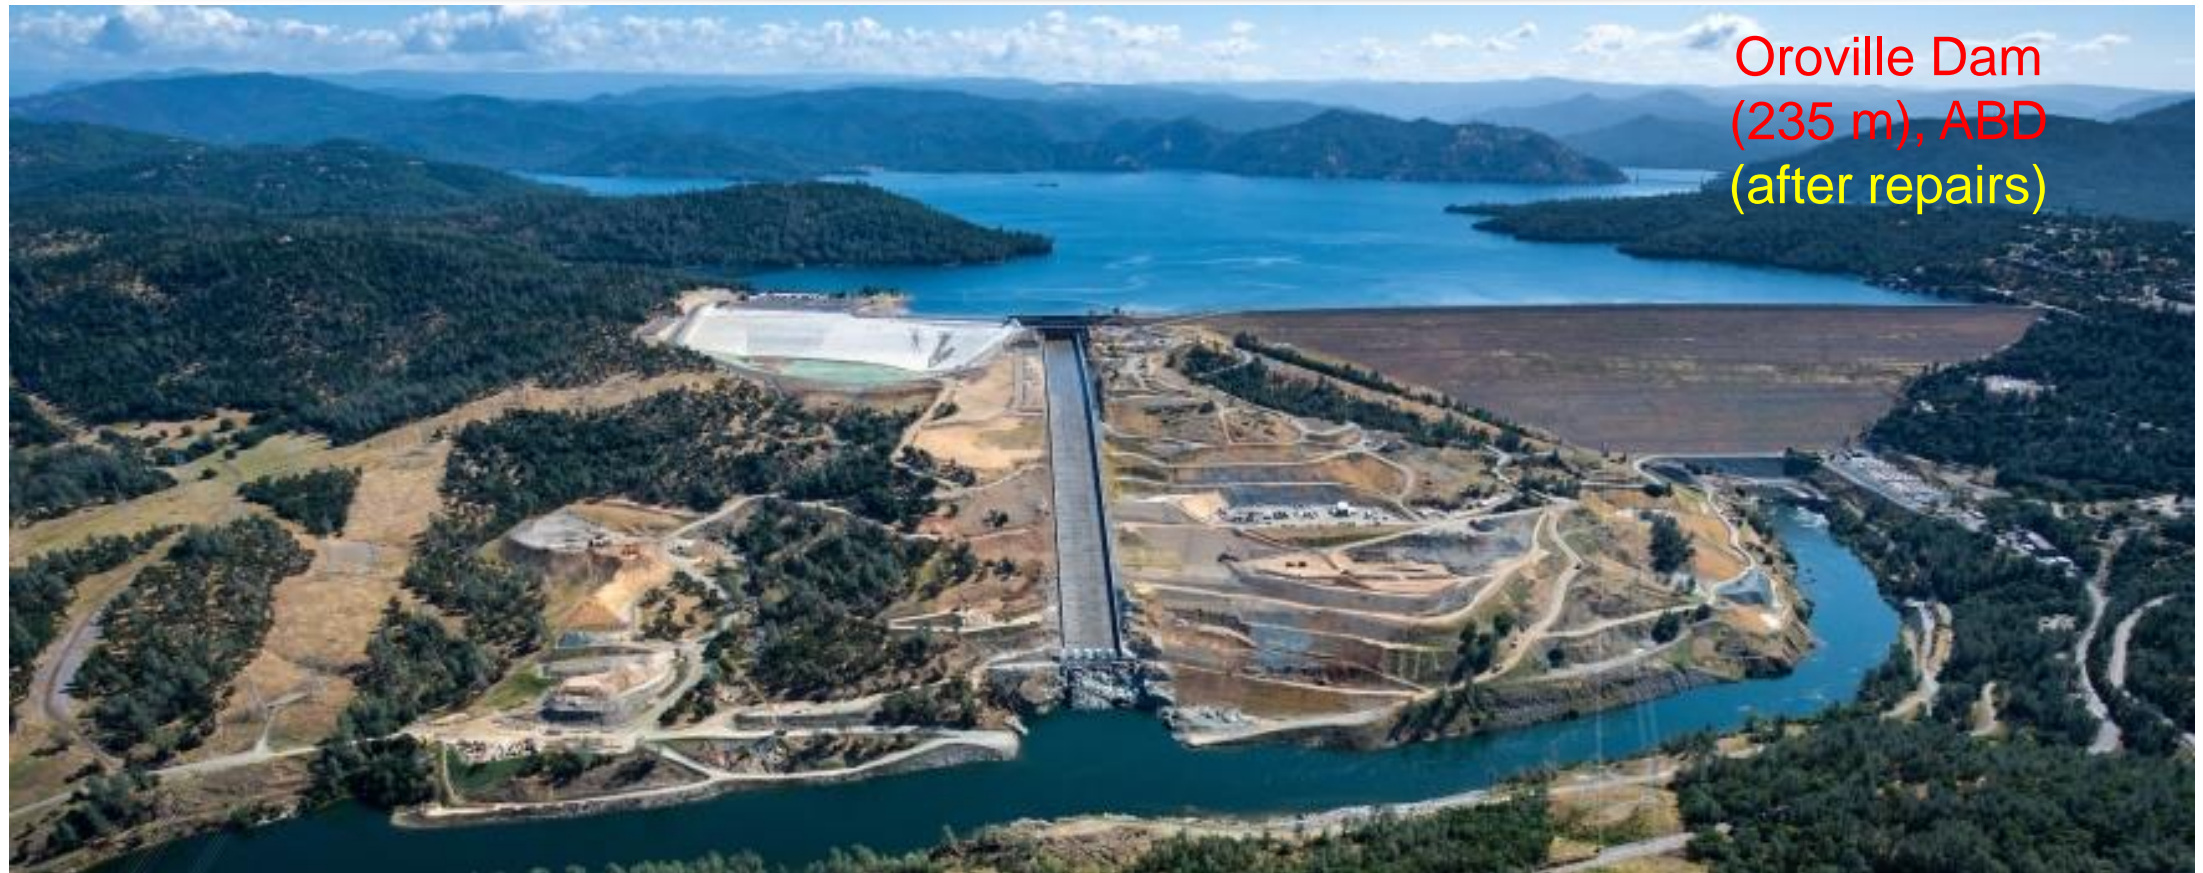
Oroville Dam
(235 m), ABD
(after repairs)

The damage was repaired, and the dam became operational again.

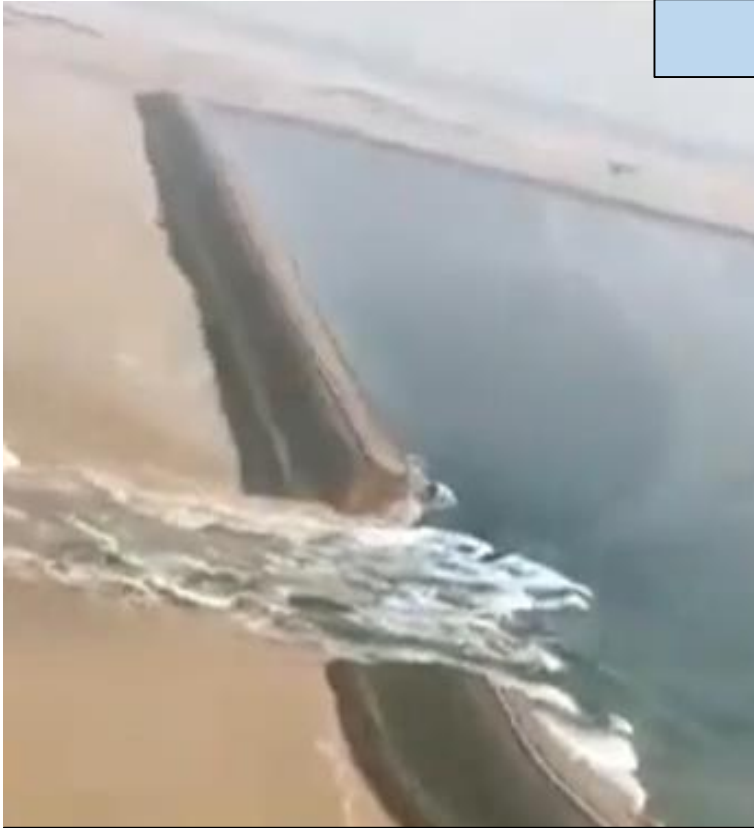
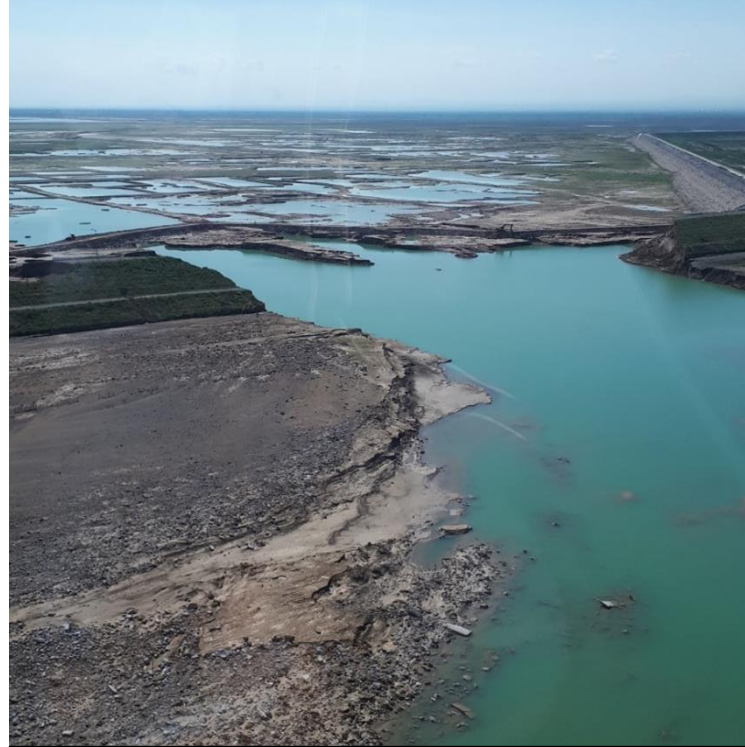
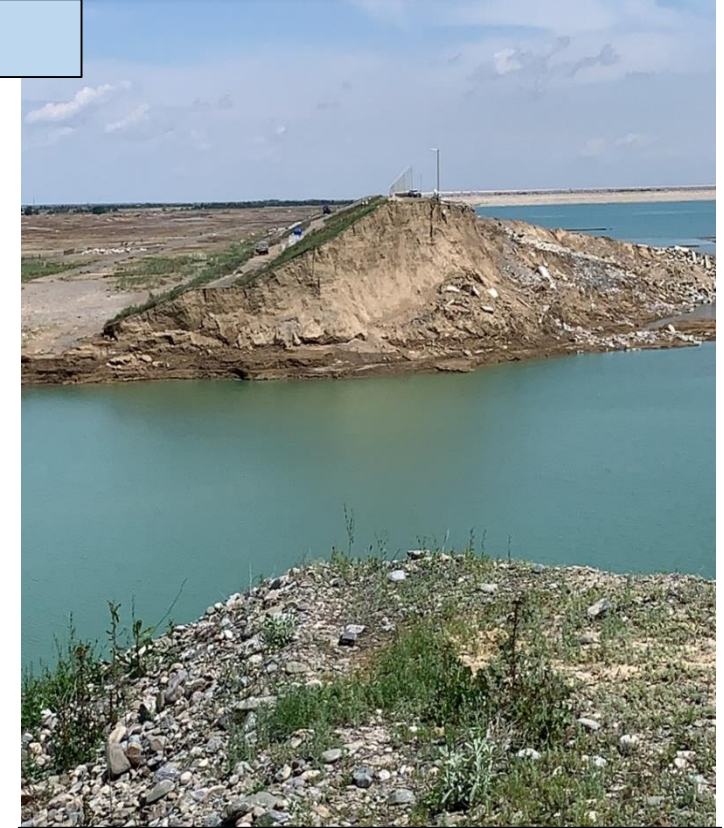
Sardoba Dam (29 m), Uzbekistan

In May 2020, the Sardoba Dam failed, causing 8 deaths and 70.000 evacuation. Estimated repair and damage cost is 500 Million \$.

An expert team by DSI visited Sardoba Dam between 18.05.2020 and 21.05.2020 to investigate the failure mechanism.

DSI team prepared a preliminary report investigating potential reasons that might trigger the collapse.

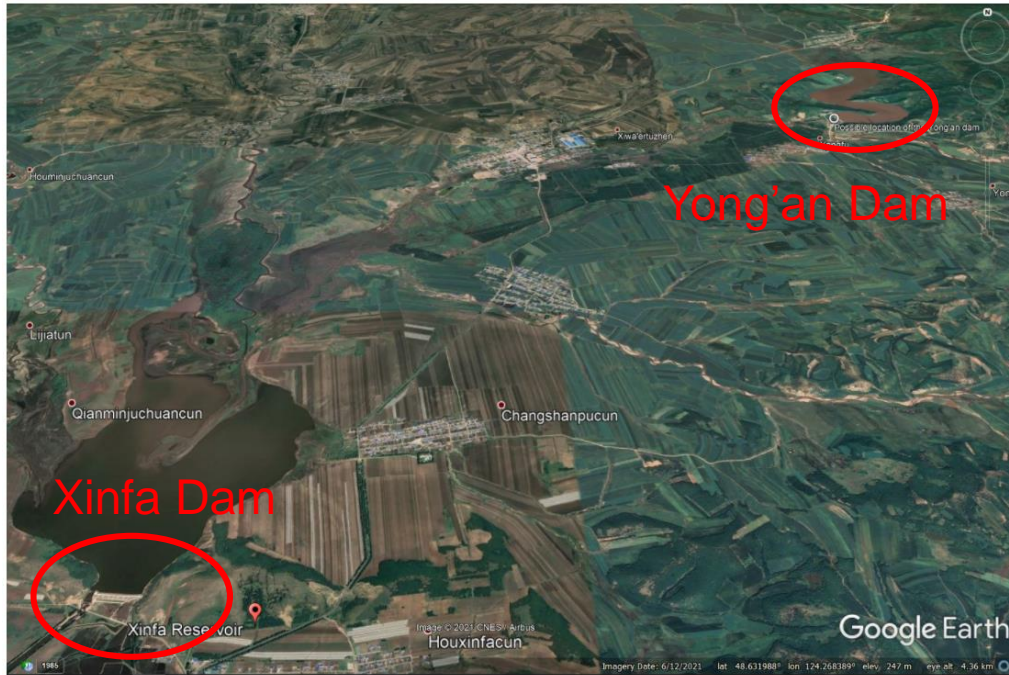
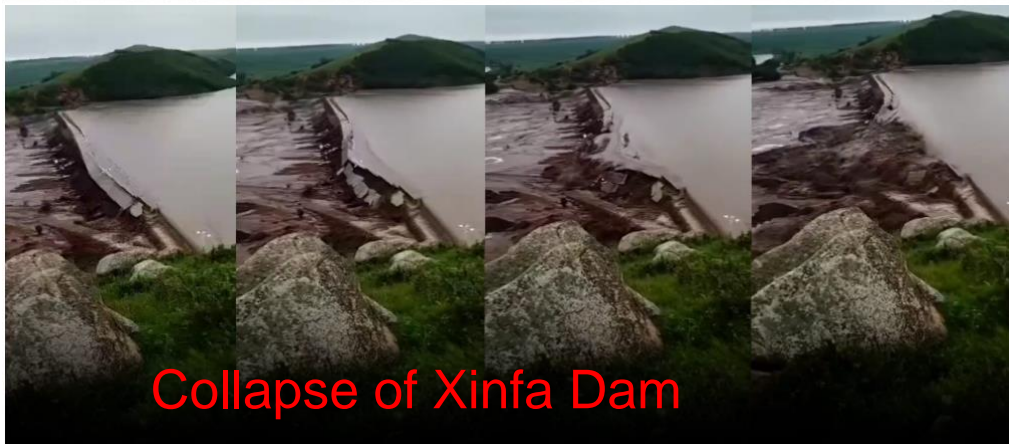
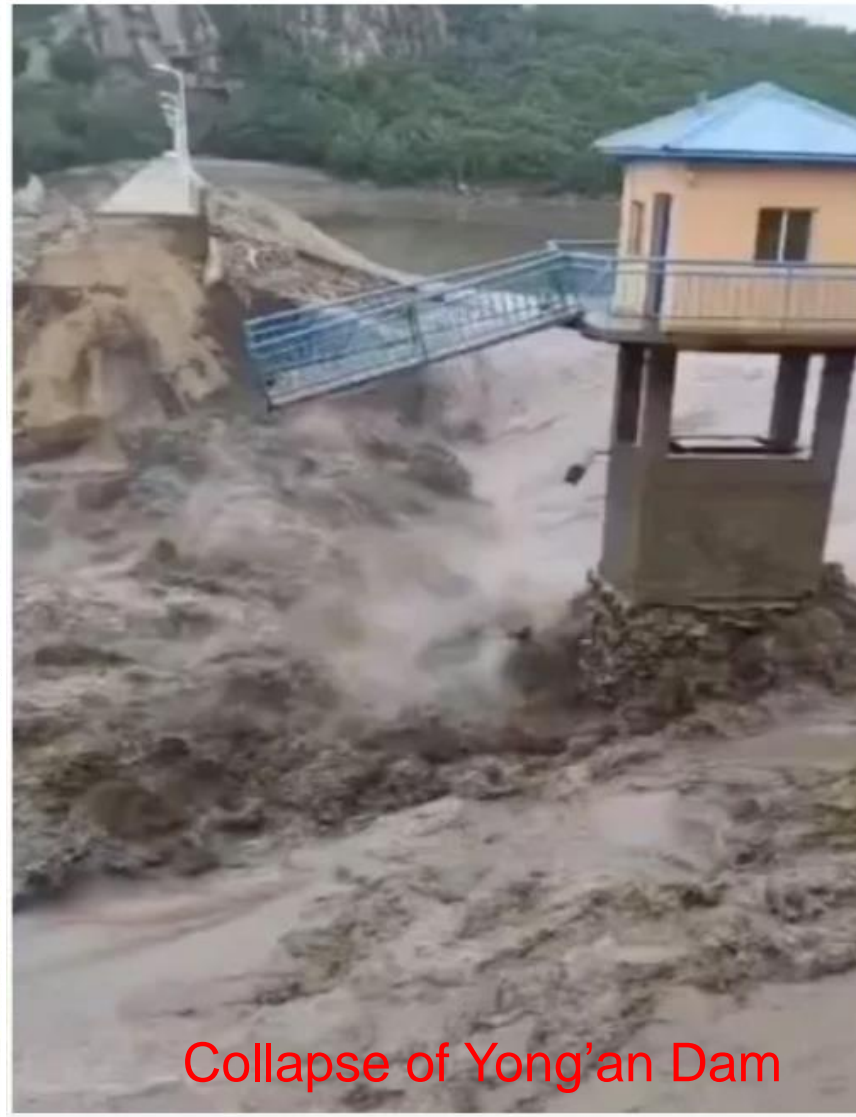
CASE STUDIES: Xinfa and Yong'an Dams

On 18th July 2021, two earthen dams in China were totally collapsed due to heavy rainfalls.

46 million m³ water was released, causing massive flooding in residential areas.

No casualties reported.
16 000 people were affected.
Bridges and transport infrastructure were destroyed in the downstream.

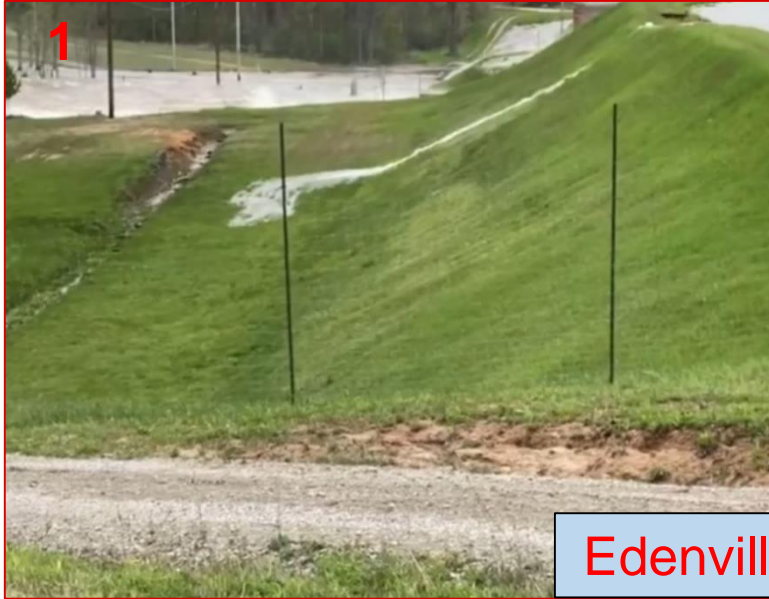
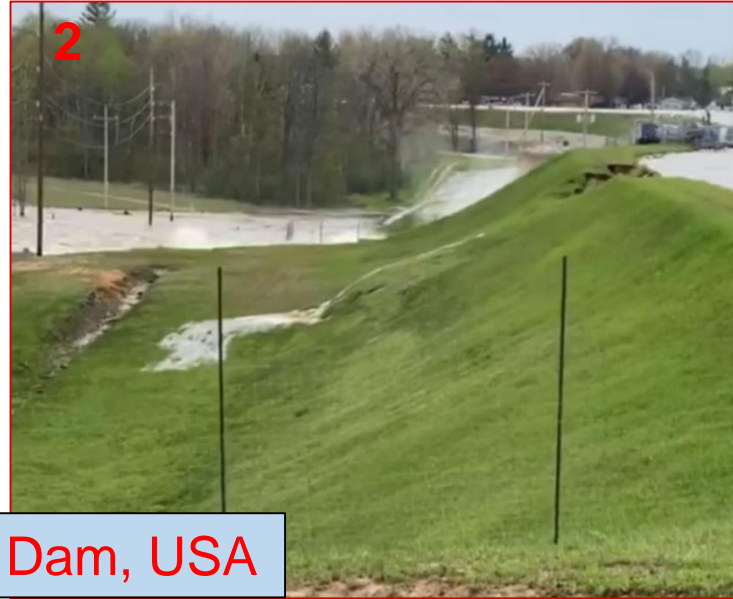
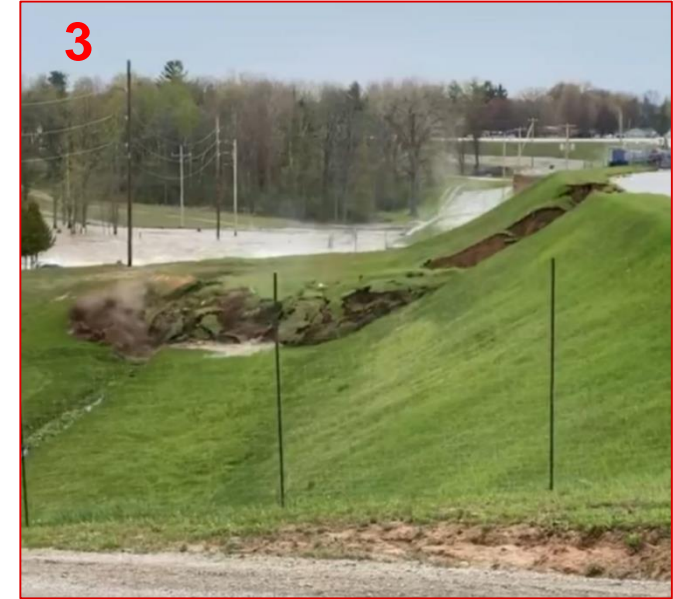
Edenville Dam, USA

In May 2020, two dams were failed due to heavy rainfalls in Michigan State, USA.

The uncontrolled water released from Edenville Dam overtopped the Sanford Dam and eventually collapsed it.

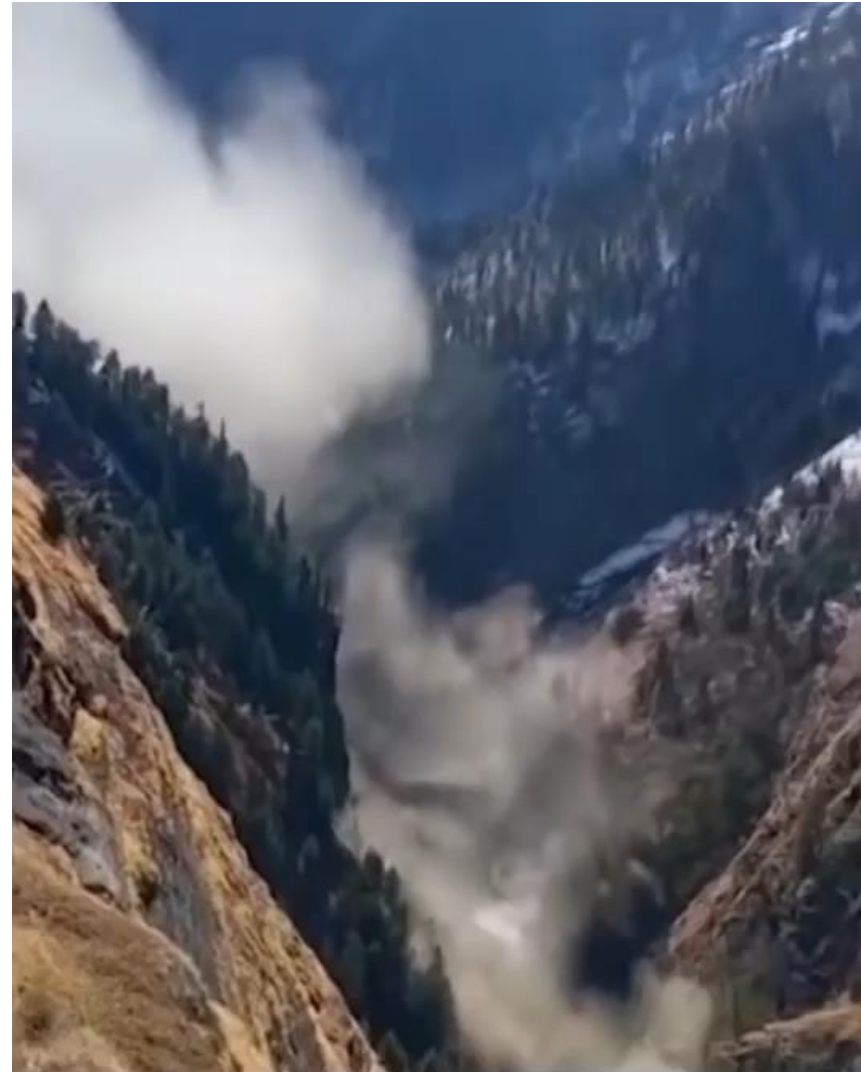
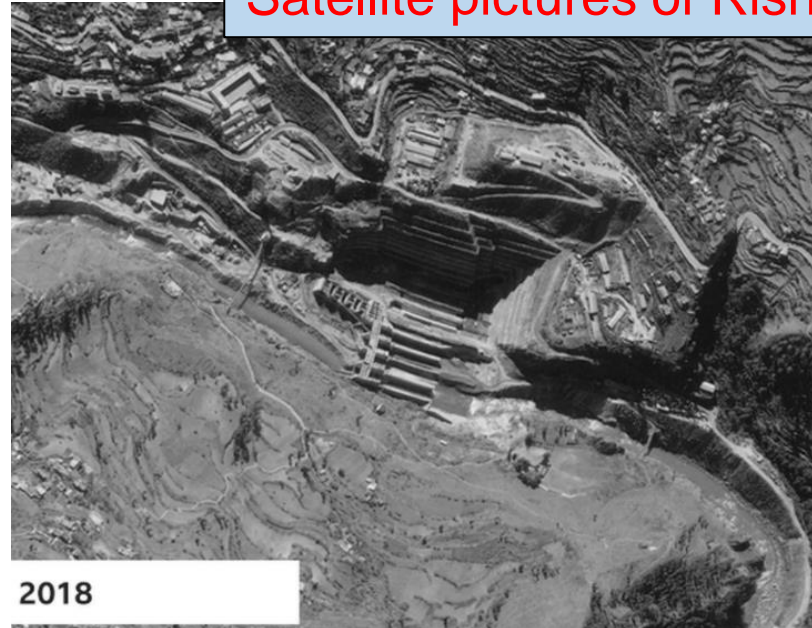
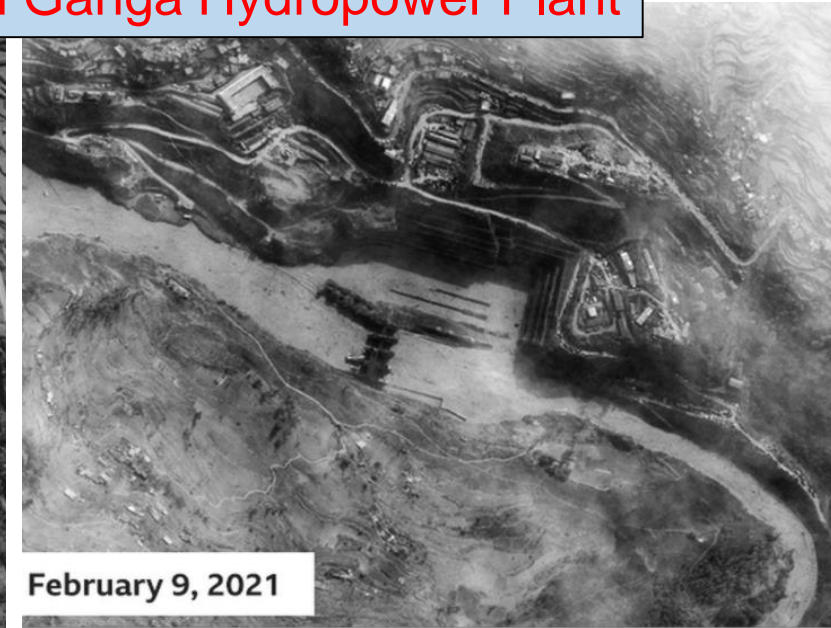
Satellite pictures of Rishi Ganga Hydropower Plant

On 7th February 2021, the devastating flood washed away two (2) Hydropower Plants.

Glacier outbursts caused the flood.

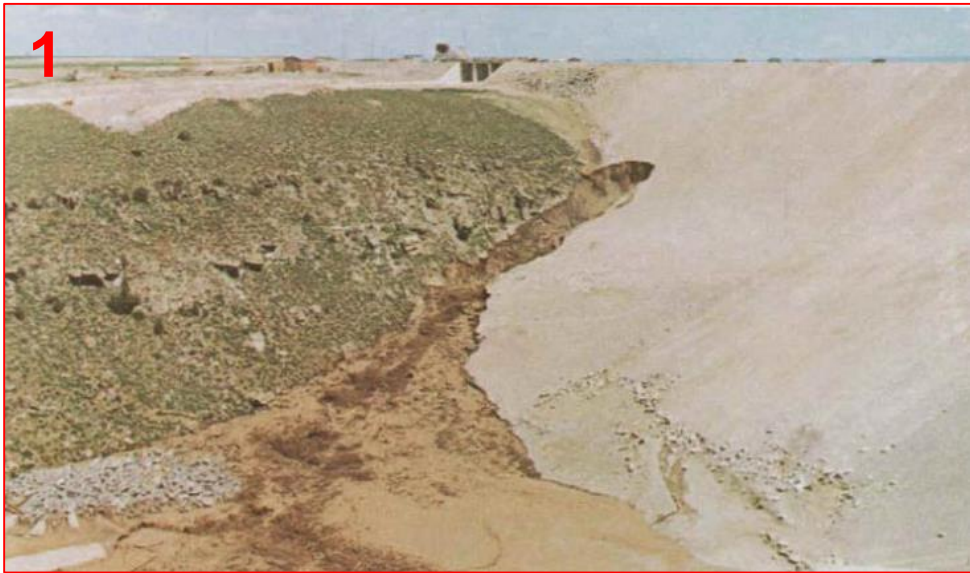
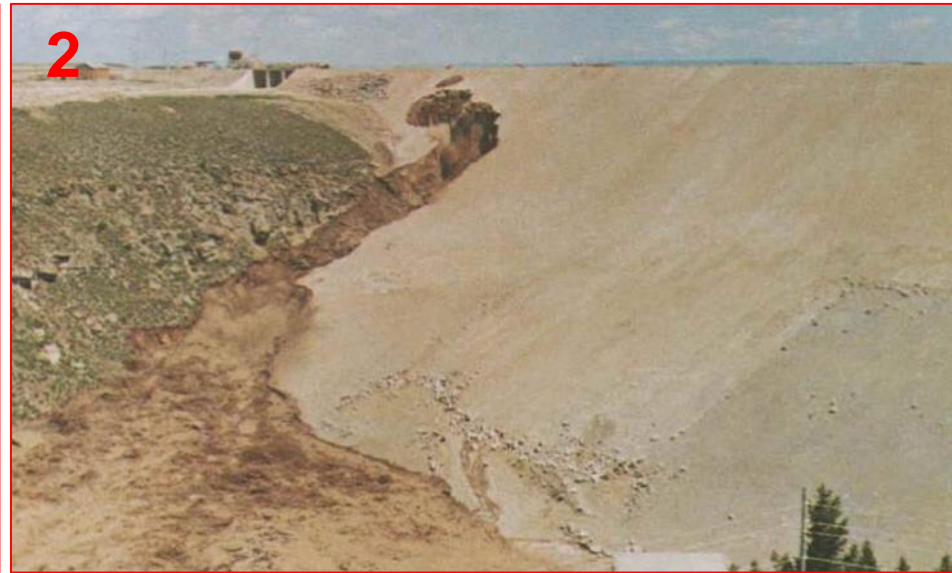
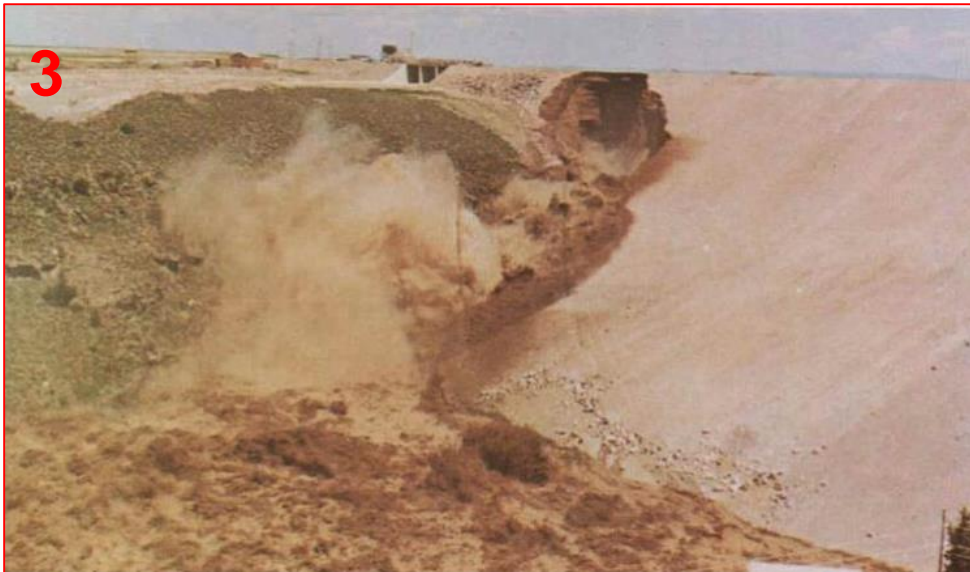
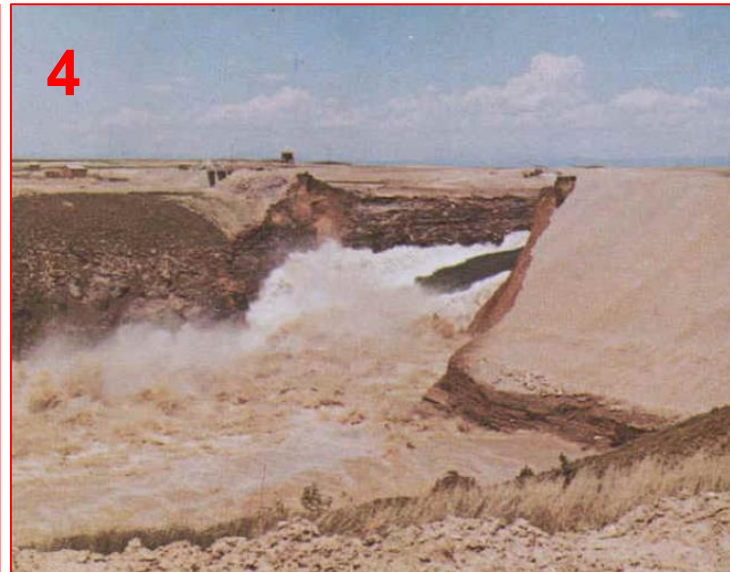
Teton Dam (93 m), USA

In 1976, during the first filling, the dam completely collapsed due to piping. 11 deaths, 400M \$ property damage.

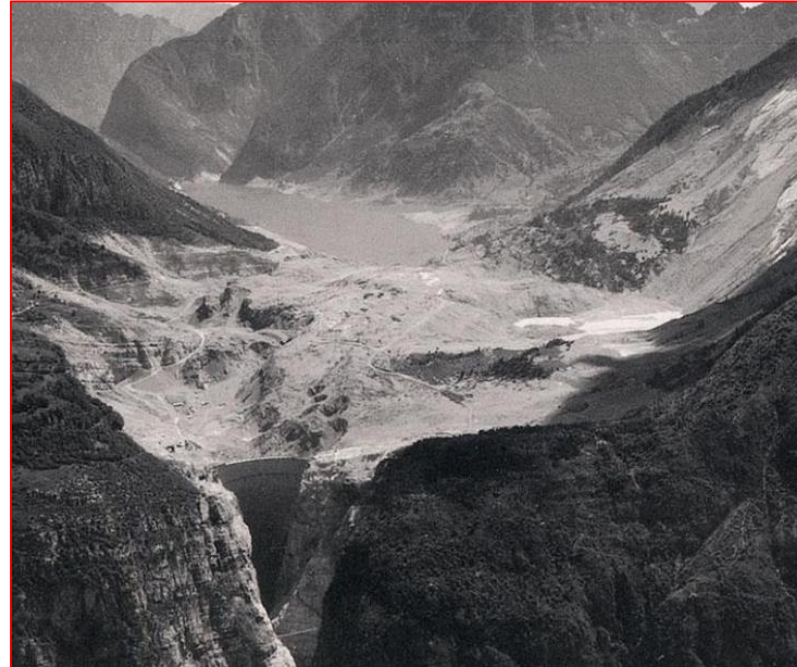
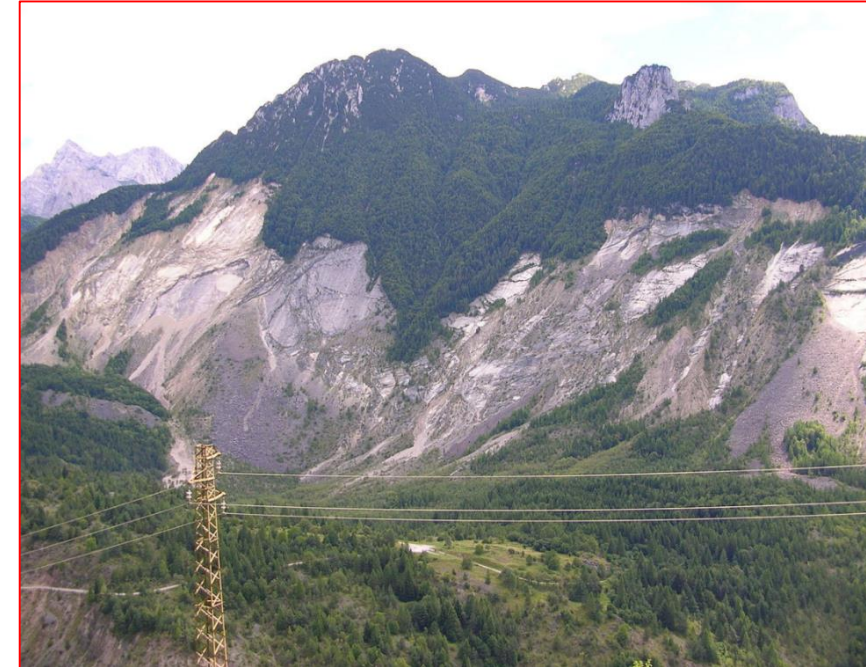
Vajont Dam (262 m), Italy

In 1963, a massive rockslide occurred in the valley basin. The volume of rockslide (267 Million m³) was about twice the reservoir water.

The water overtopped the dam, causing 2056 deaths. The dam body sustained very little damage and still remains in place today with no water holding behind. (damfailures.org)

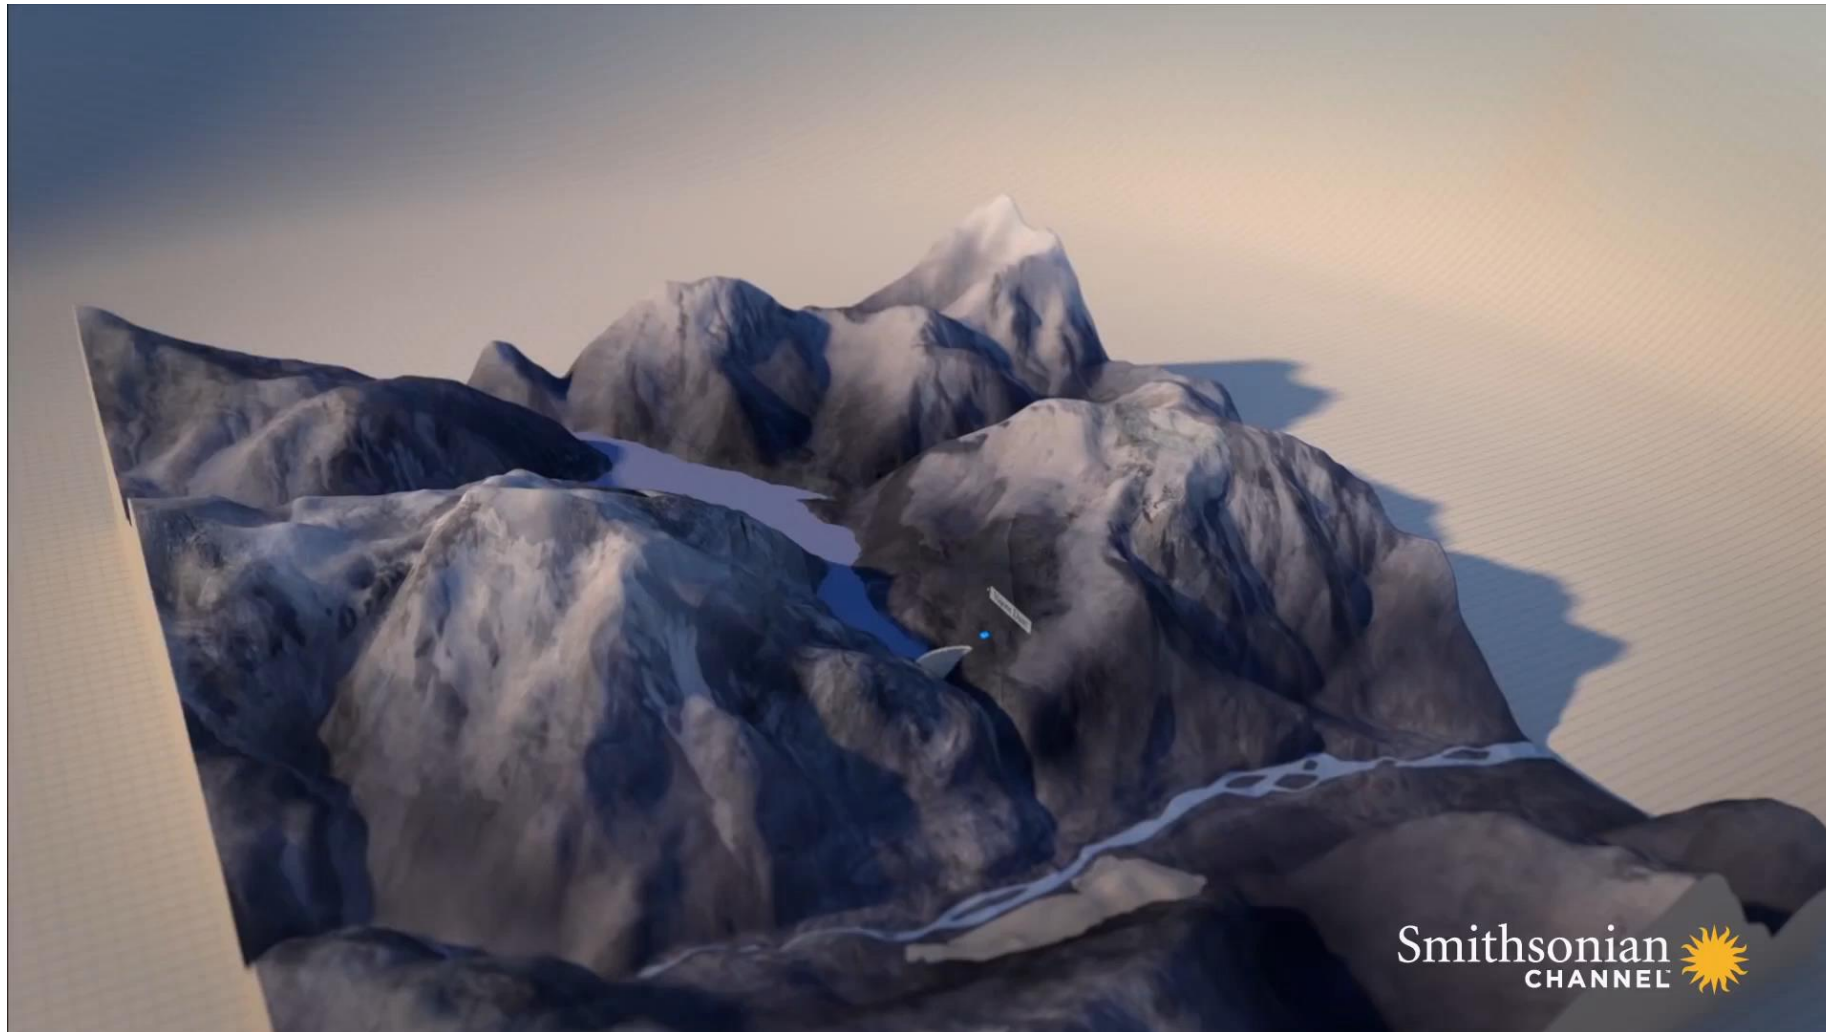
CASE STUDIES: Vajont Dam

Failure mechanism of Vajont Dam
