Dam Safety Practices in Turkey

Mutlu İlker Peker

The General Directorate of State Hydraulic Works of Turkey

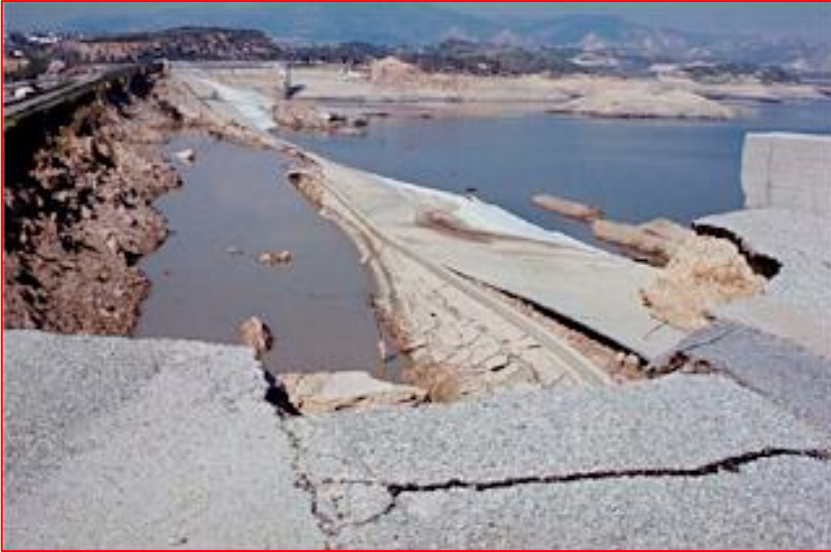
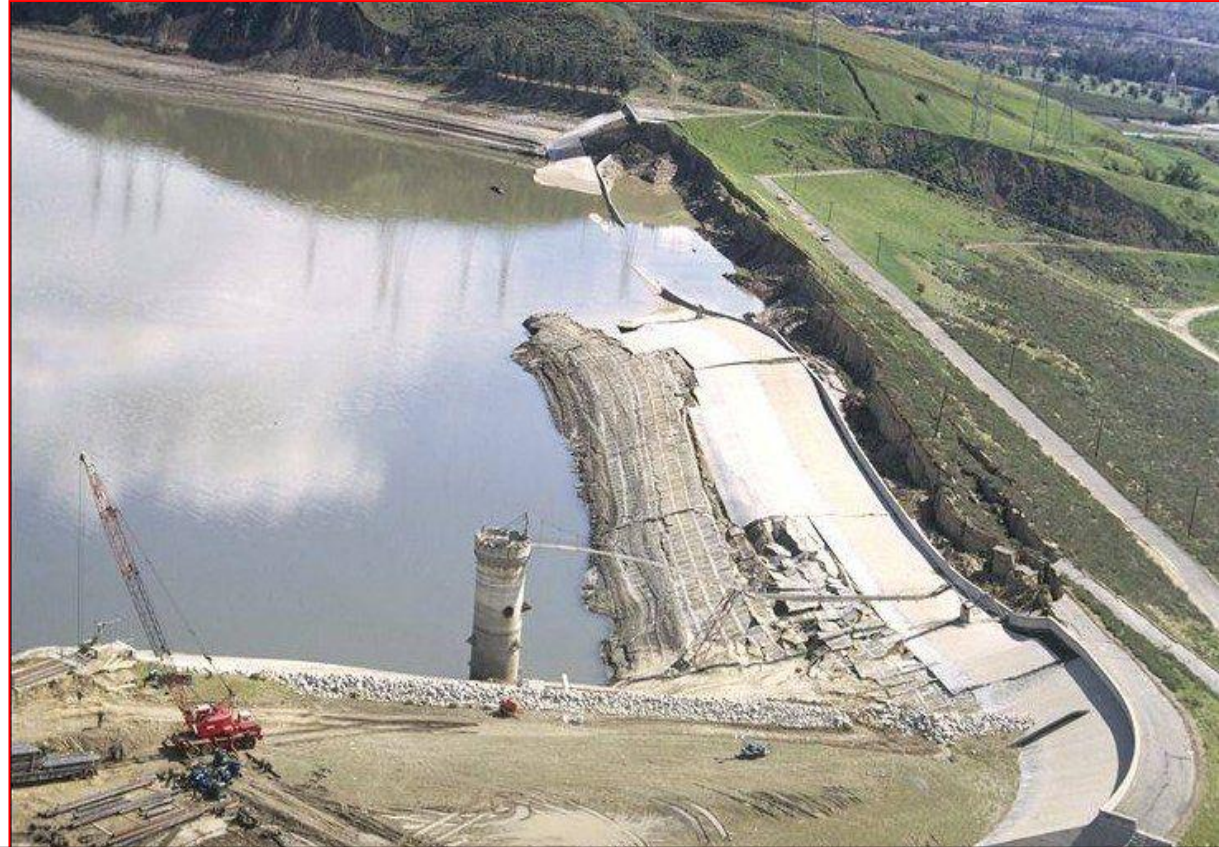
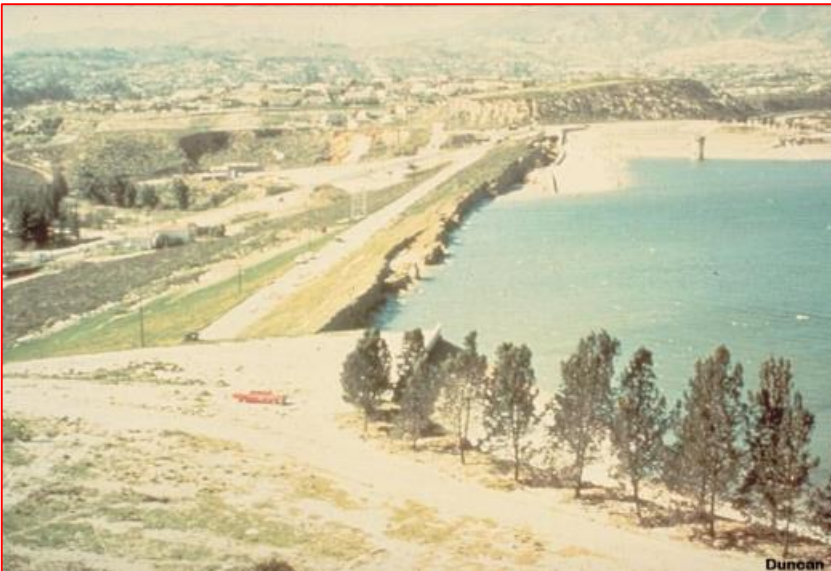
Lower San Fernando Dam (43 m), USA

After San Fernando Earthquake in 1971 ($M_w = 6.6$)
The dam crest remained above the reservoir water level after earthquake-induced settlements, which prevented a total collapse.

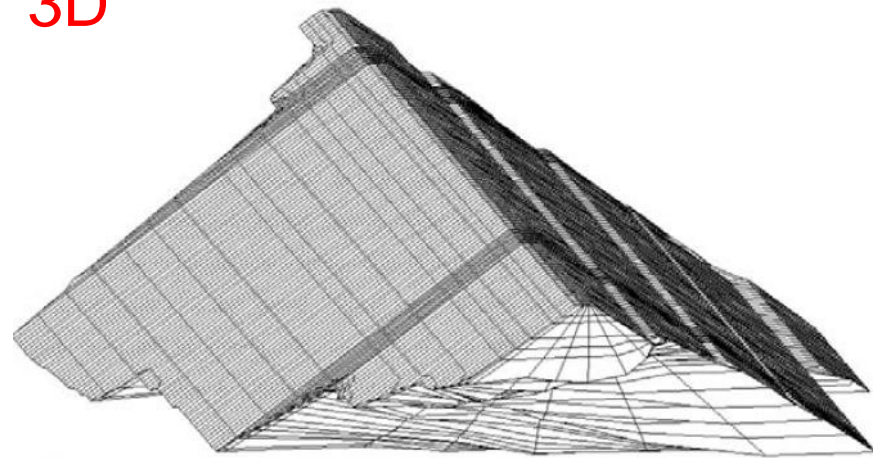
3D

**Ilisu Prof. Dr. Veysel Eroğlu Dam
(Mardin)
CFRD, (131 m)**

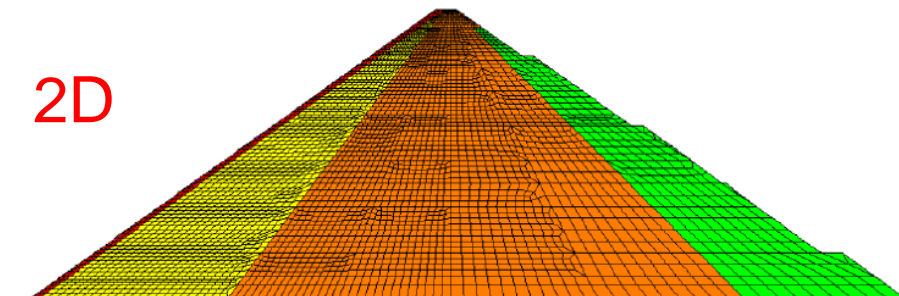
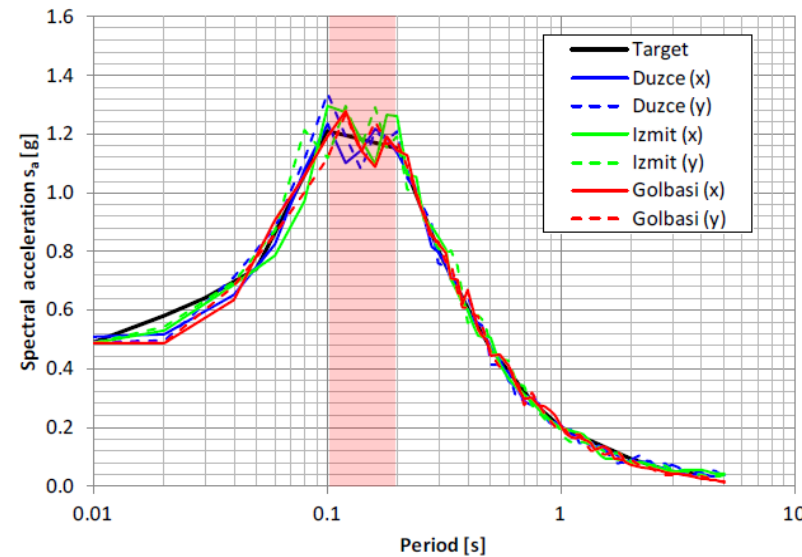
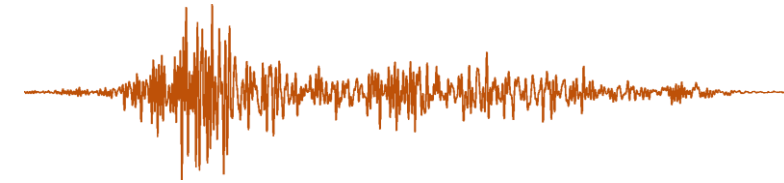
2D

After design spectra is defined, the ground motions with similar characteristics are selected for dynamic analyses.

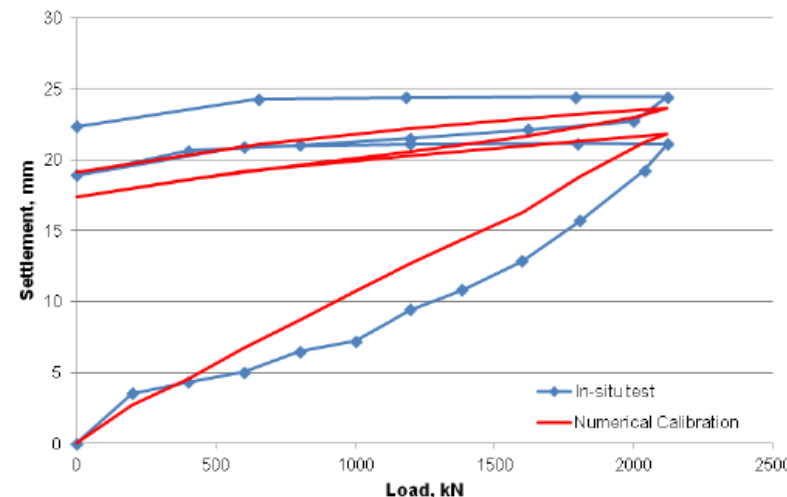
In-situ experiments conducted on rockfill material are compared with numerical results for calibration.

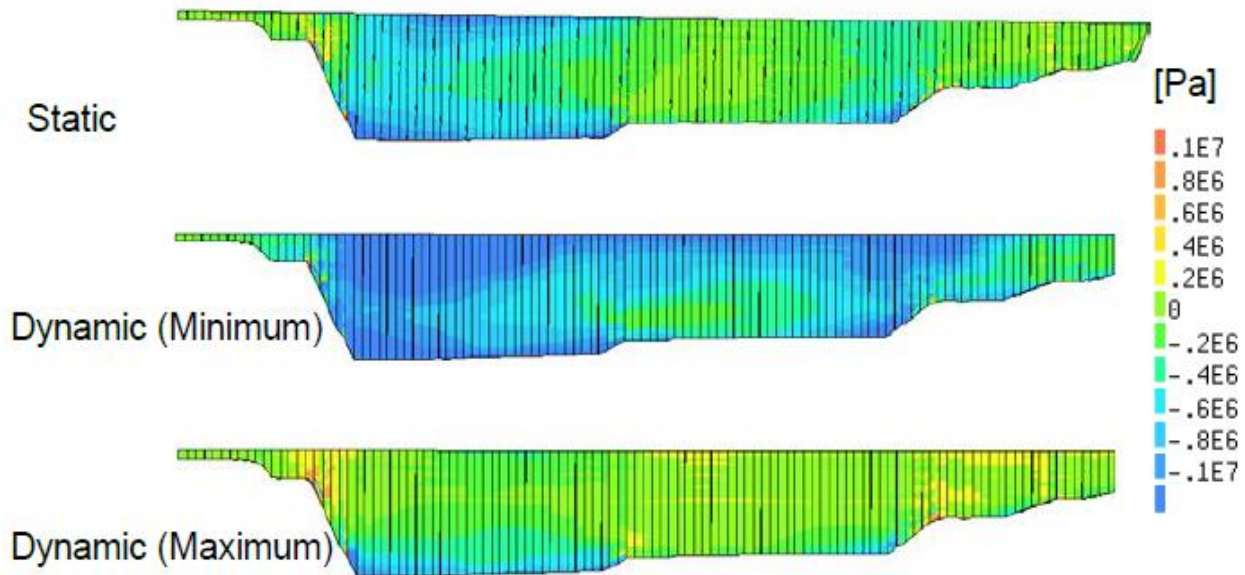
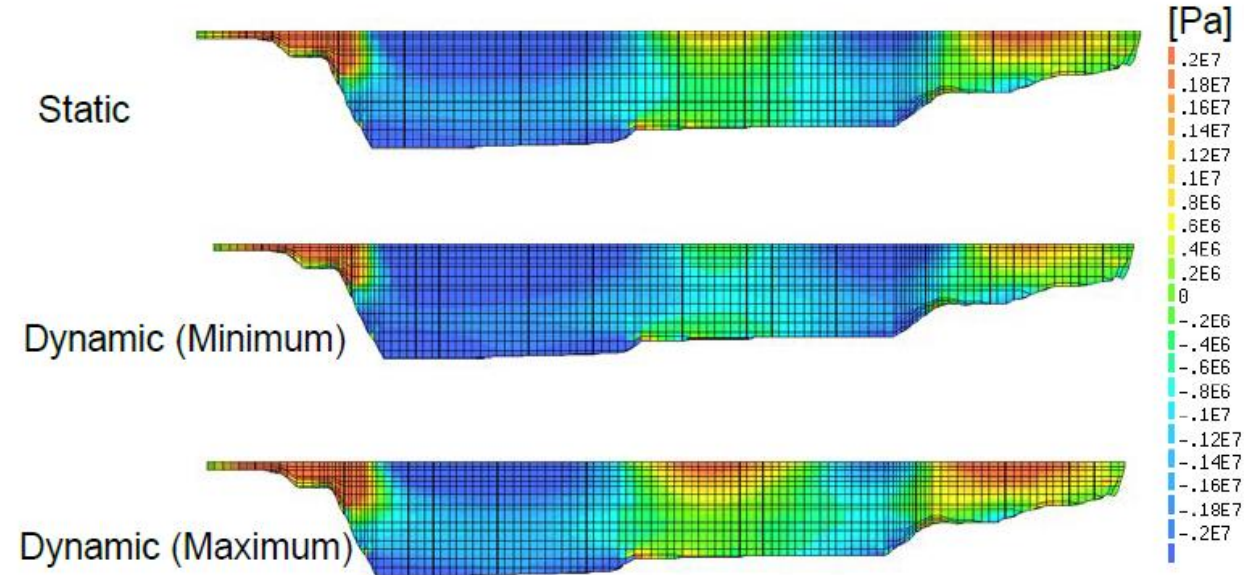
EXAMPLE FOR DYNAMIC ANALYSES

Estimated stresses in the concrete face when compressible joints are modelled.

Estimated stresses in the concrete face when compressible joints are not modelled.

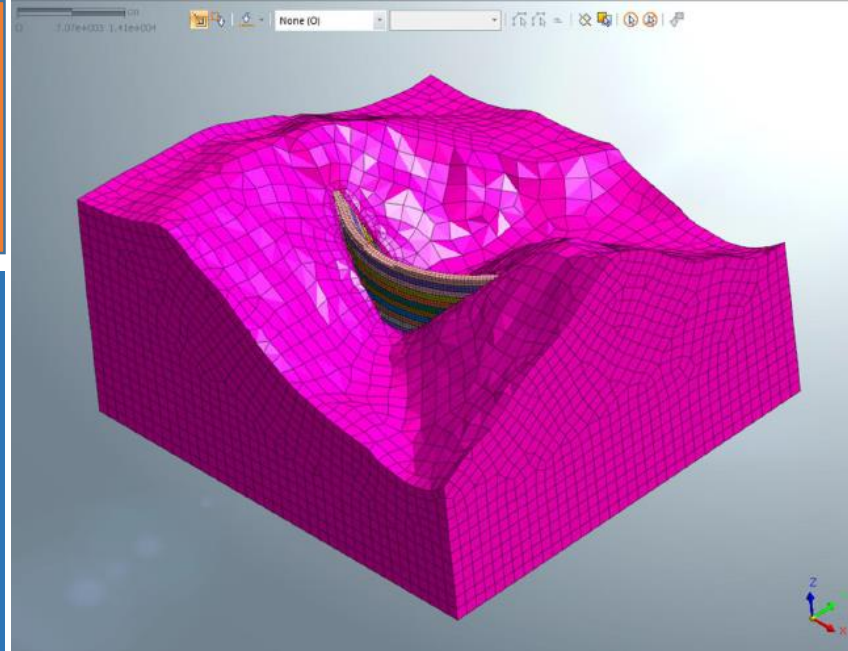
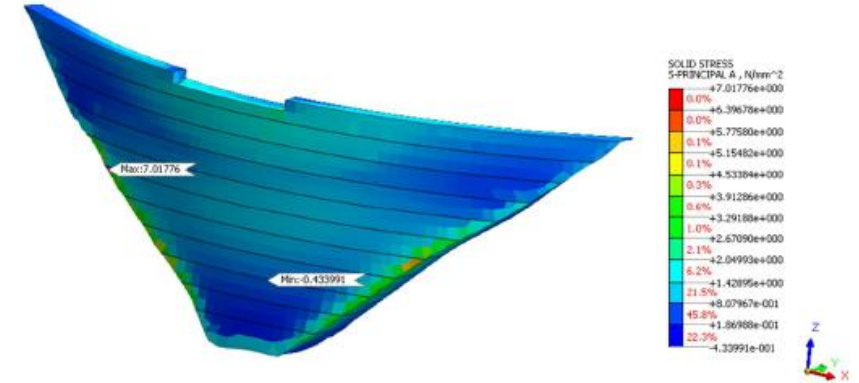
Şekil 3.79: EED_302_H1 (Irpinia, Italy-02) – Maksimum Asal Çekme Gerilmeleri

**Söylemez Dam
(Erzurum)
RCC + Arch (113 m)**

In complex geometries, the topography and 3D modelling are involved in numerical modellings.

[DATA] 2475_0302_H1, 2475_0302_H1, MAX, [UNIT] N, mm

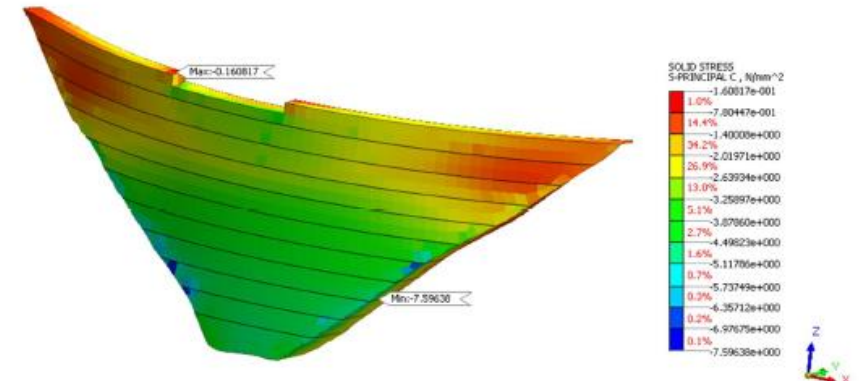
Şekil 3.80: EED_302_H1 (Irpinia, Italy-02) – Minimum Asal Basınç Gerilmeleri

[DATA] 2475_0302_H1, 2475_0302_H1, MIN, [UNIT] N, mm

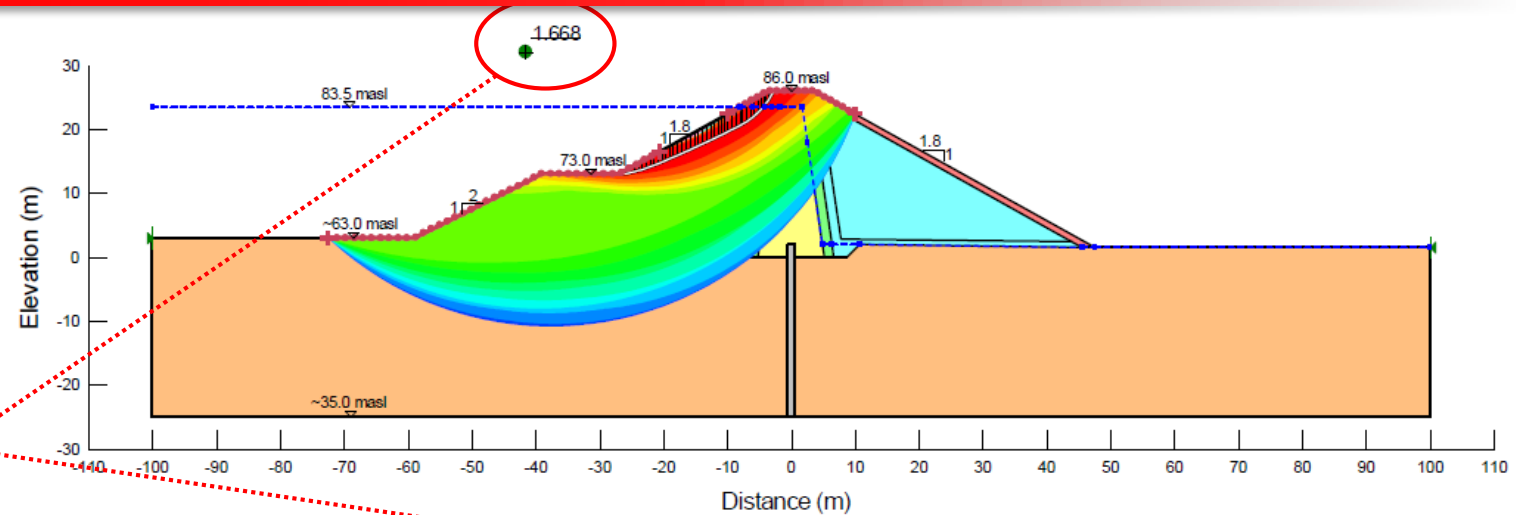
Şekil 6-18: Memba Yamacı Stabilité Analizi. İşletim Durumu – Statik (FSL)

Factor of Safety for slopes stabilities is estimated as 1.68 and 1.56 (>1.5).

The safety factors on upstream and downstream slopes meet the required criteria.

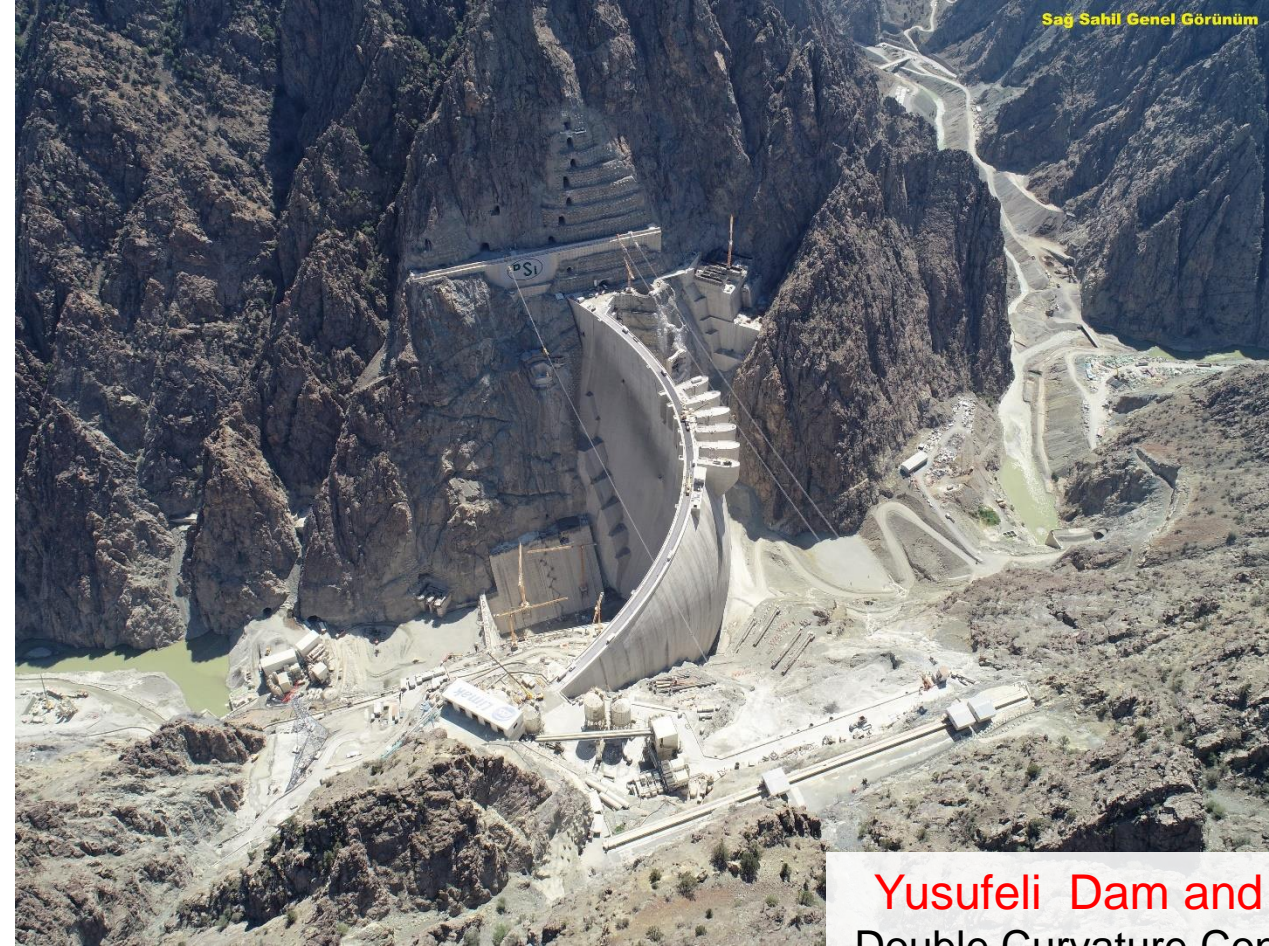
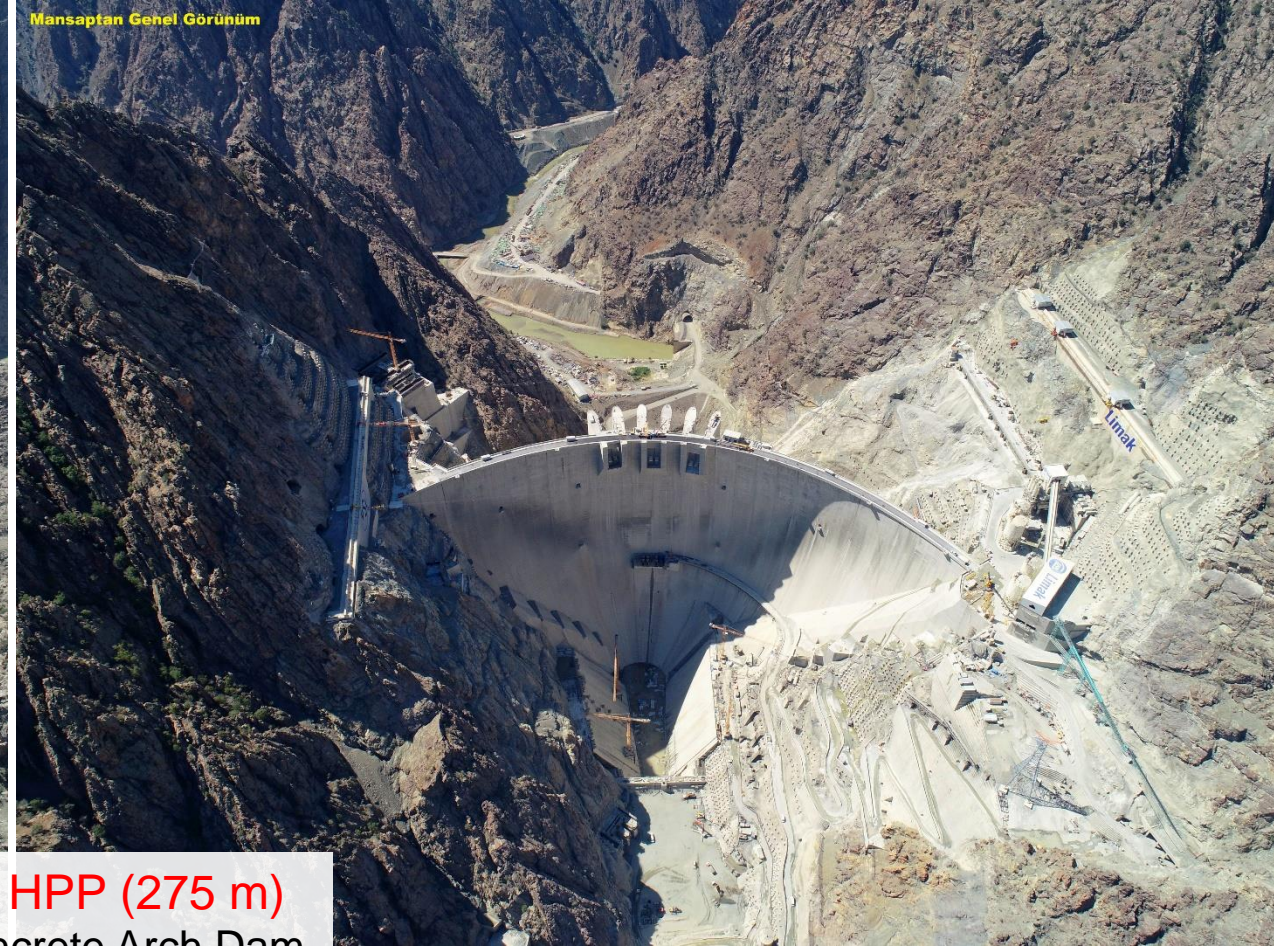
Yusufeli Dam and HPP (275 m)
Double Curvature Concrete Arch Dam
540 MW (3 Units)

Sağ Sahil Genel Görünüm

Mansaptan Genel Görünüm

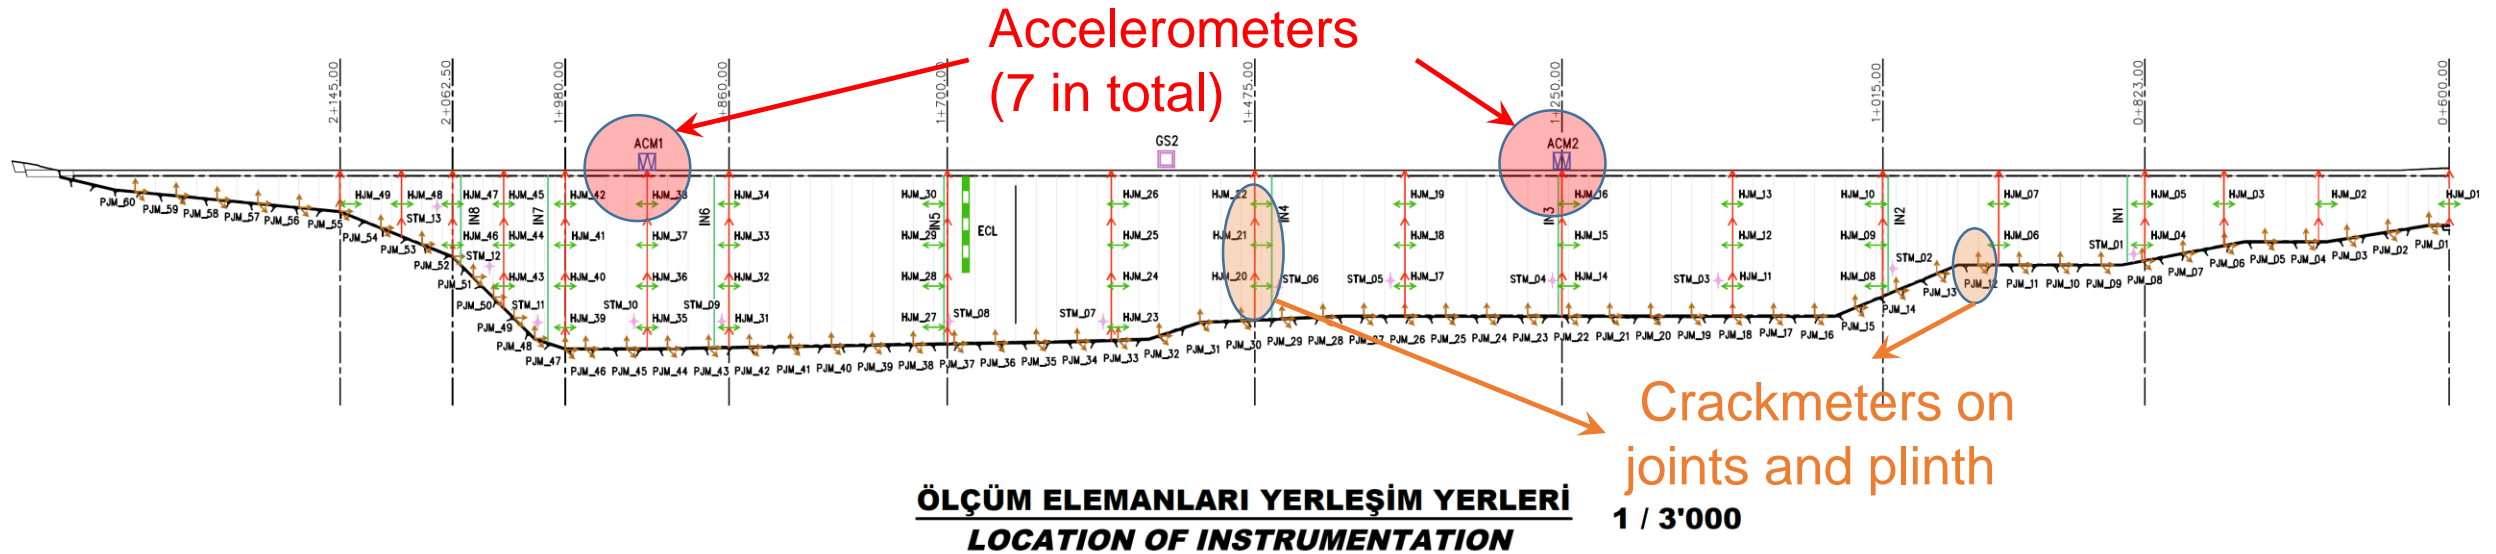
ILISU PROF. DR. VEYSEL EROĞLU DAM and HEPP - INSTRUMENTATION

INSTRUMENTS	NO	INSTRUMENTS	NO	INSTRUMENTS	NO
Piezometers (foundation)	141	Accelerometers	7	Extensometers	16
Lateral Extensometer	42	Water Level Meter	1	Flow Meter	5
Pressure Cells	106	Strain Gages	45	Temperature Sensors (short term)	39
Hydraulic Settlement Cells	93	Fiber Optic Leakage Detector	1	Temperature Sensors (long term)	18
Magnetic Extensometers	4	Benchmarks	57	Strain Meters (with thermometers)	18
Inclinometers	8	Pendulum	4	Water Temperature Sensor	1
Crack Meters	163	Inverted Pendulum	4	Weather Station	1

**Total
774**

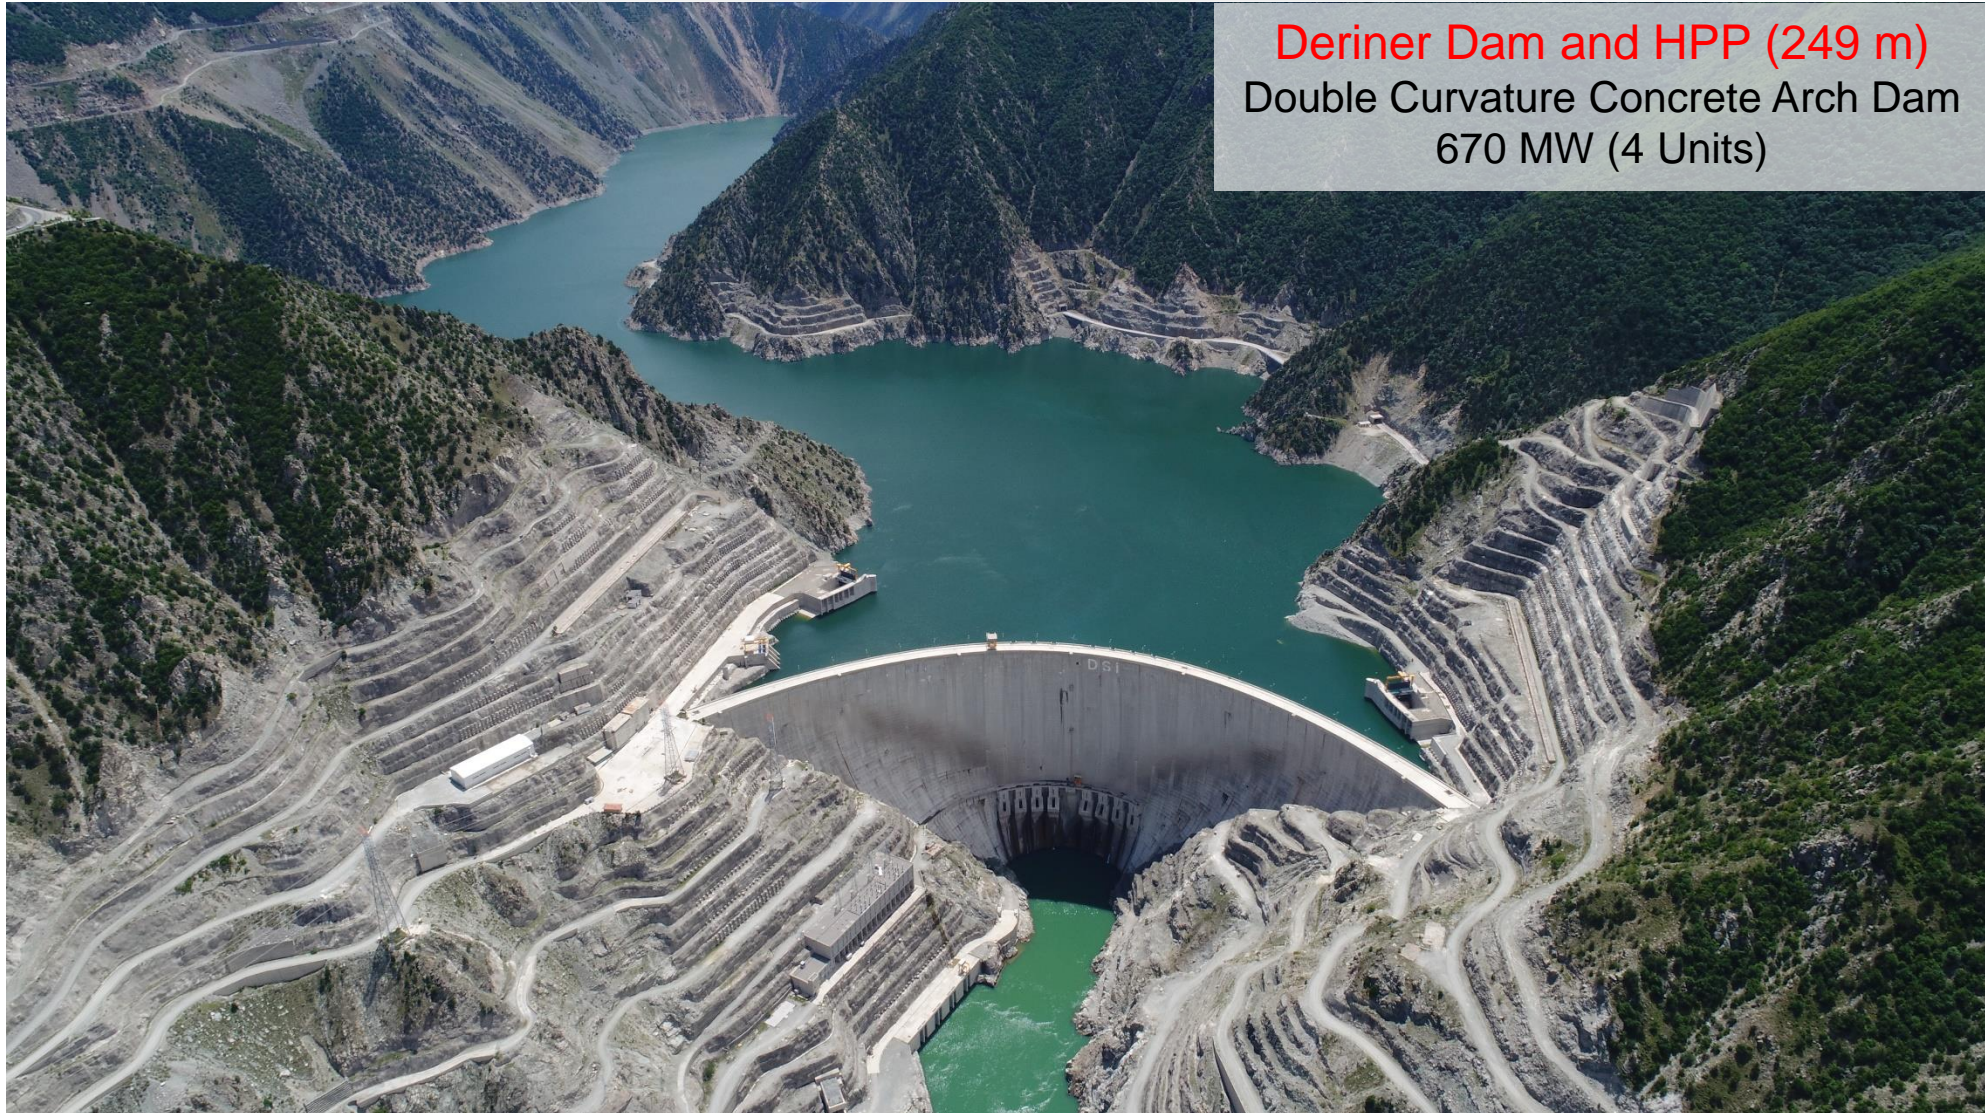
DERİNER DAM and HEPP

Deriner Dam and HPP (249 m)
Double Curvature Concrete Arch Dam
670 MW (4 Units)

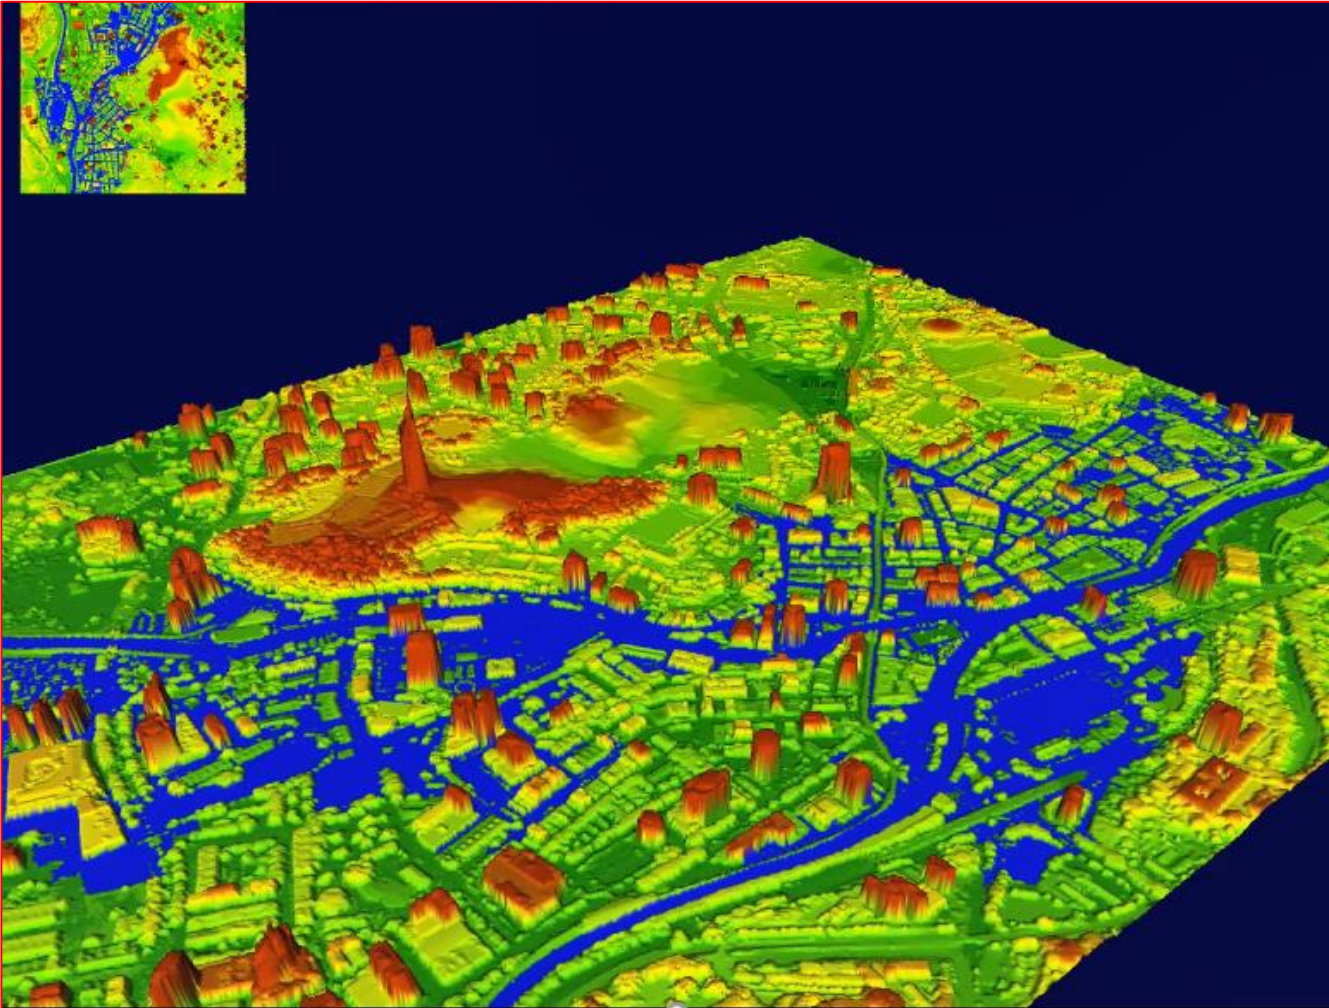
İZMİR ÜRKMEZ DAM - DAM BREAK ANALYSIS

Dam break analysis of Urkmez Dam, located in city of Izmir, was performed.

The flood hazard maps are produced for emergency preparedness plan.

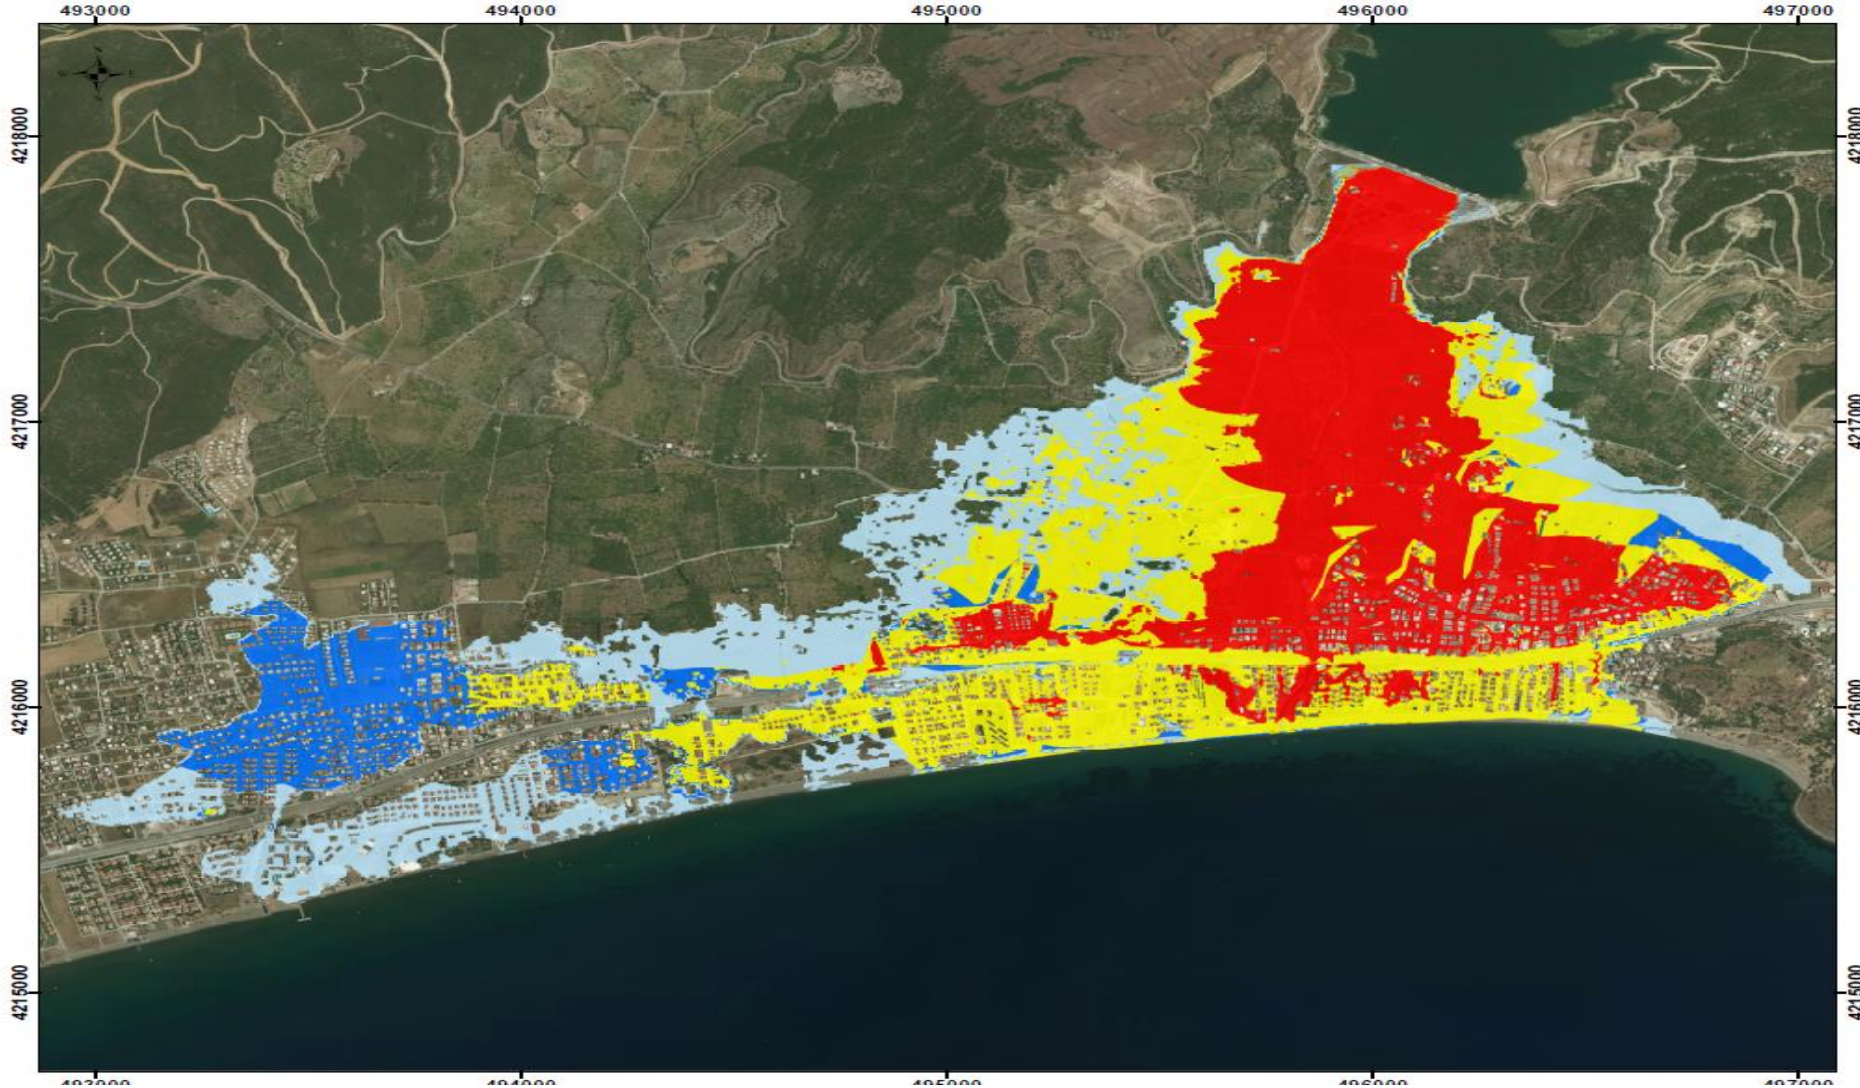
İZMİR ÜRKMEZ DAM - DAM BREAK ANALYSIS

Tehlike Dereceleri

- Düşük (0 - 0.75)
- Orta (0.75 - 1.25)
- Yüksek (1.25 - 2.5)
- Çok Yüksek (> 2.5)

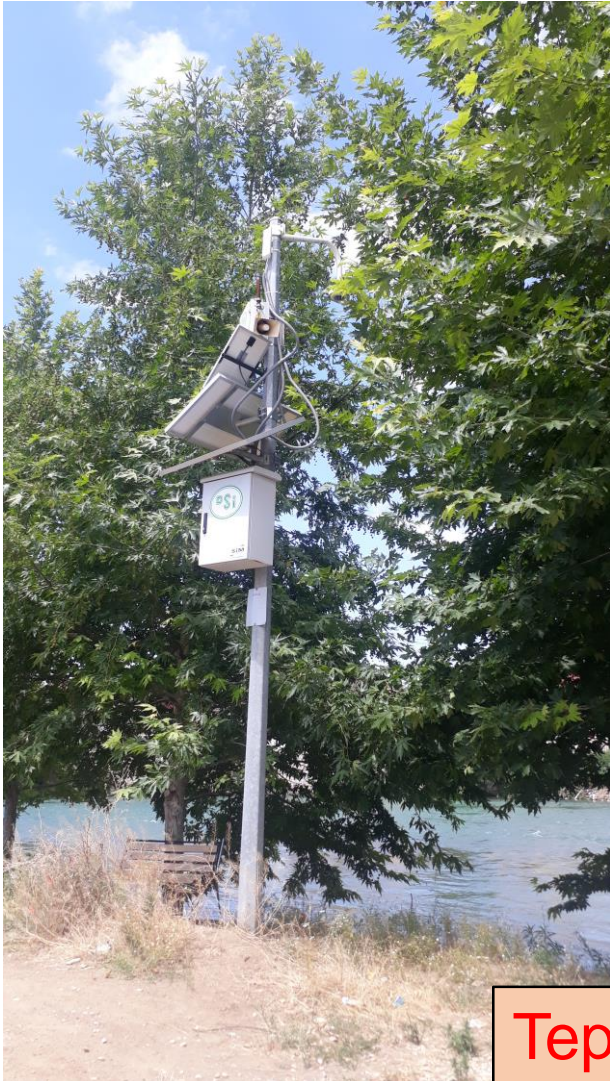
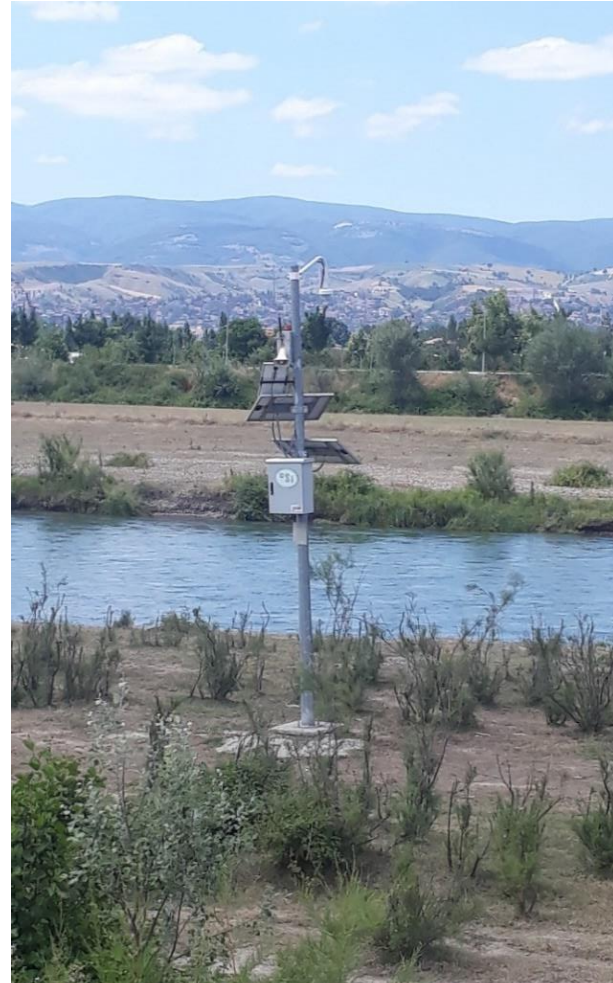
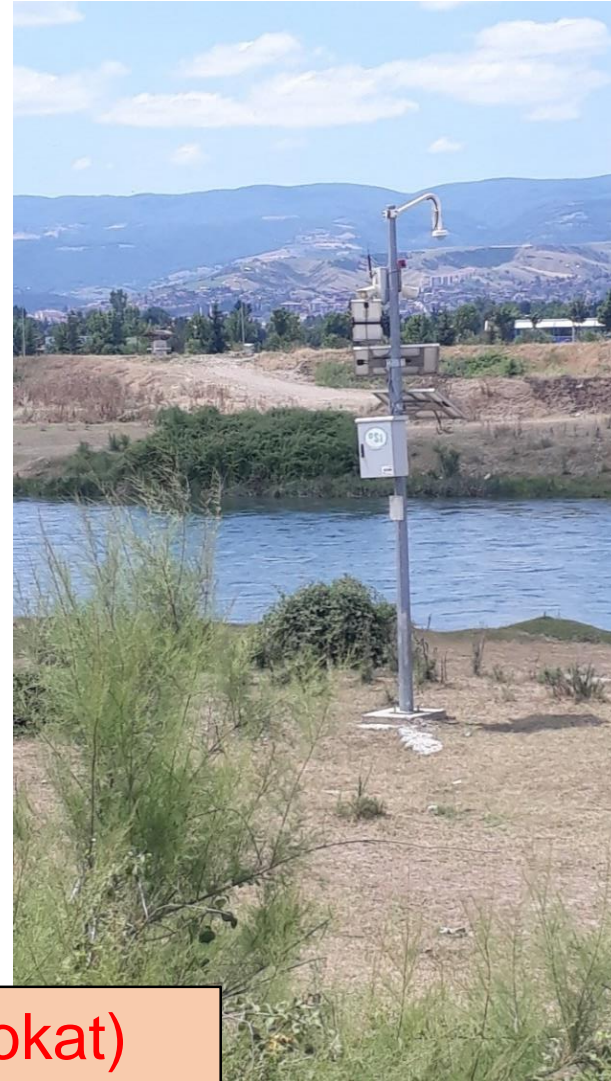
Tepekışla Dam ve HPP(Tokat)

After the flood hazard maps are produced, early warning systems are installed in downstream residential areas as part of emergency preparedness plans.

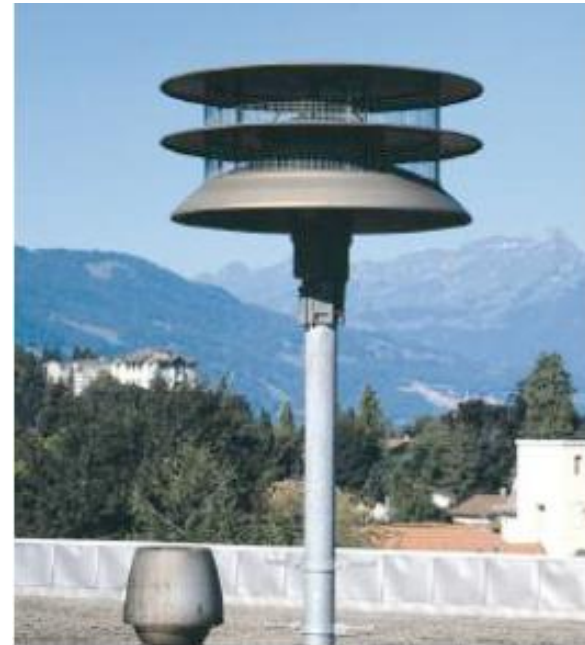
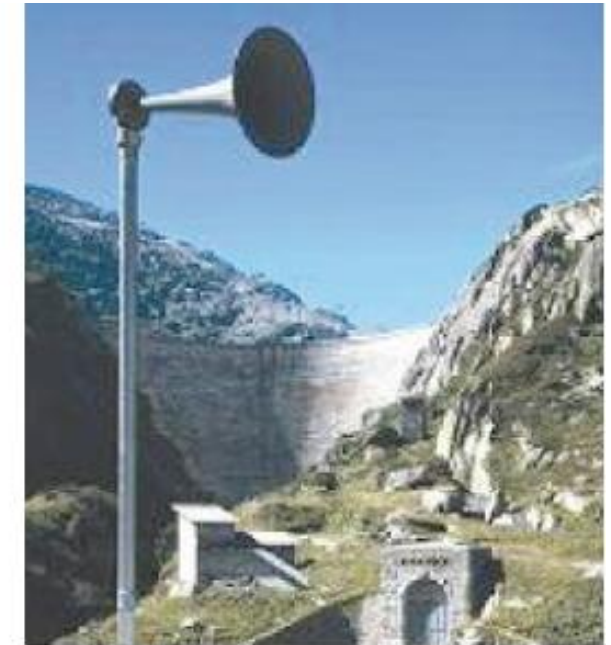
EARLY WARNING SYSTEMS

Water alarm sirens(left) and general alarm sirens (right).
